Service Bulletin

Bulletin No.: 21-NA-169

Subject: Diagnostic Tip for DTCs Set at a Low Mileage for 9T45/50/60 Automatic Transmissions

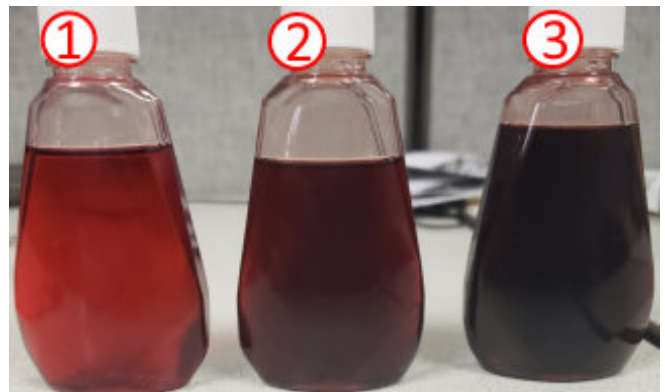
5840393

7. While the vehicle is idling, remove the oil level set plug (1). Allow any fluid to drain:
 - If the fluid is flowing as a steady stream, wait until the fluid begins to drip.
 - If no fluid comes out, add fluid until fluid drips out.
8. Record fluid level; overfilled, under-filled, correct on repair order and how much was needed to fill or came out:
 - If fluid is overfilled, set correct level and retest.
 - If fluid is under-filled, inspect for external leaks. Refer to *Fluid Leak Diagnosis* in SI.
