Technical Information

FROM: Maserati TSO

Grecale - New Granturismo: air suspension system check

DATE: May 1, 2024

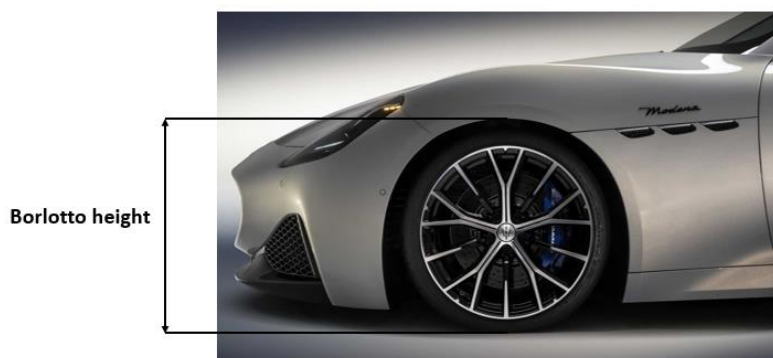
- b) read the height from the ground to the highest point of each front wheel arch (**borlotto height** – see image on page 3 of pdf for clarification) with the scan tool in VDCM ECU - 7005 - Vertical Dynamic Ride Height Sensors – and indicate the values in the check list table at the end of section 1 of the bulletin

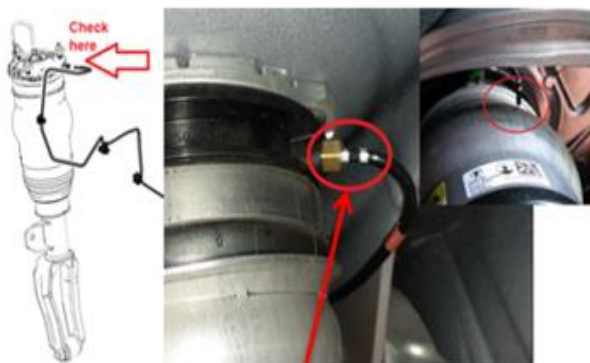
1 – Front axle

Sample of incorrect Air Suspension pipe installation on the front Air spring

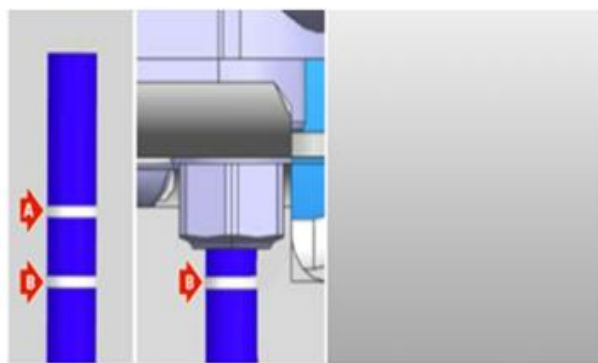
Correct layout to be ensured on the vehicle (points A and B)

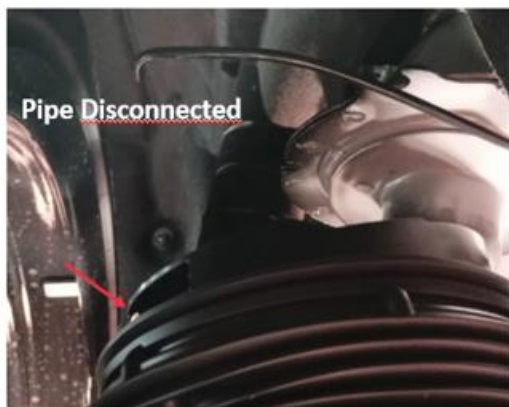
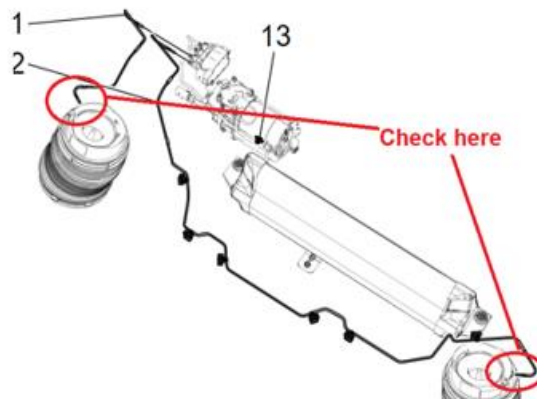
2 – Rear axle

Sample of incorrect Air Suspension pipe installation on the Rear Air Spring

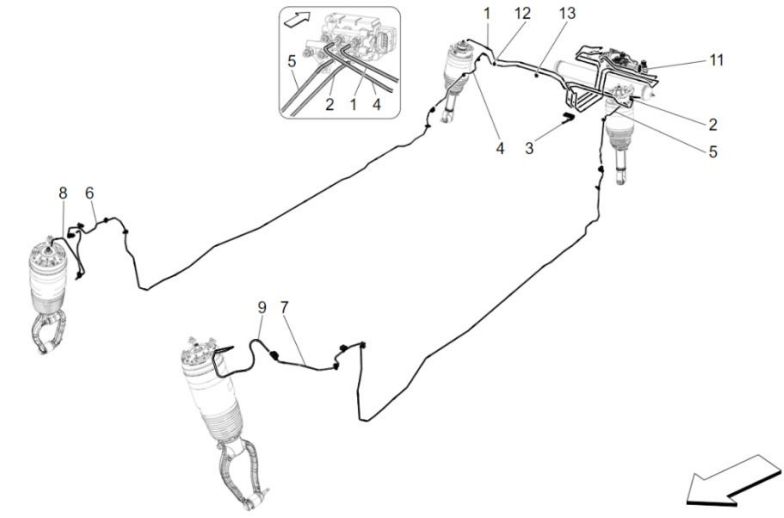
Old configuration

3b – Pipe connection area – New Granturismo (check the connections for at least 5-10 minutes with one of the products indicated at the end of this document)

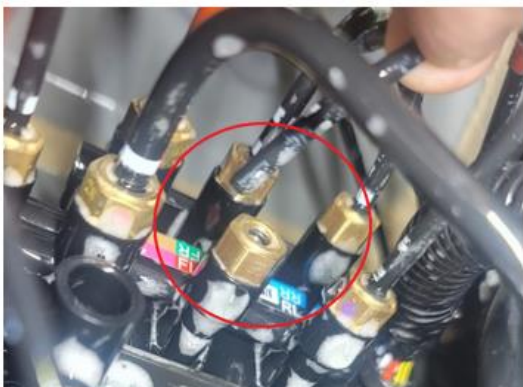
4 – Air Valves Block pipes – disconnected or wrongly fitted (check the connections for at least 5-10 minutes with one of the products indicated at the end of this document)

Check the air valves block pipes to ensure that there isn't any disconnected and/or wrongly installed line

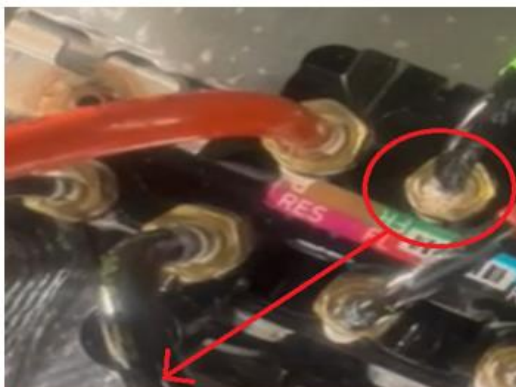
Use soapy water to detect potential air leak through the system

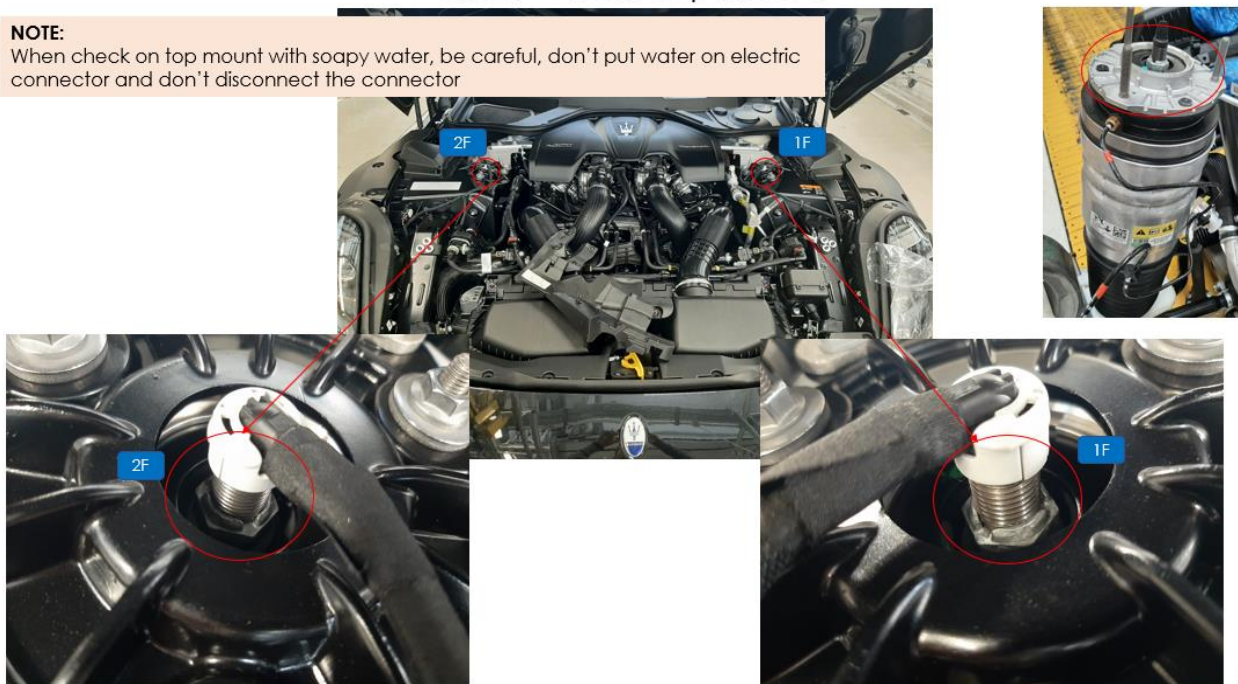
M189 – Front Top Mount

When check on top mount with soapy water, be careful, don't put water on electric connector and don't disconnect the connector

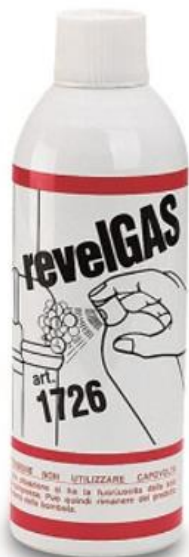
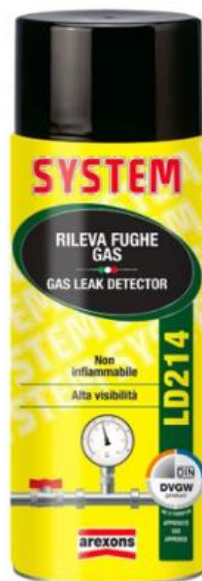
Products to be used to check for any leakage in the air suspension system.

- Kemper 1726 revel gas
- Arexons System LD214 gas leak detector
- 1000 Bulles Air Liquide gas leak detector
