**Diagnostic Sheet**

# Ghibli QP Levante DTC P0090

DATE: May10, 2024

**MODELS:** M157 Ghibli V6, M156 Quattroporte V6 and M161 Levante V6(MY 22-23).

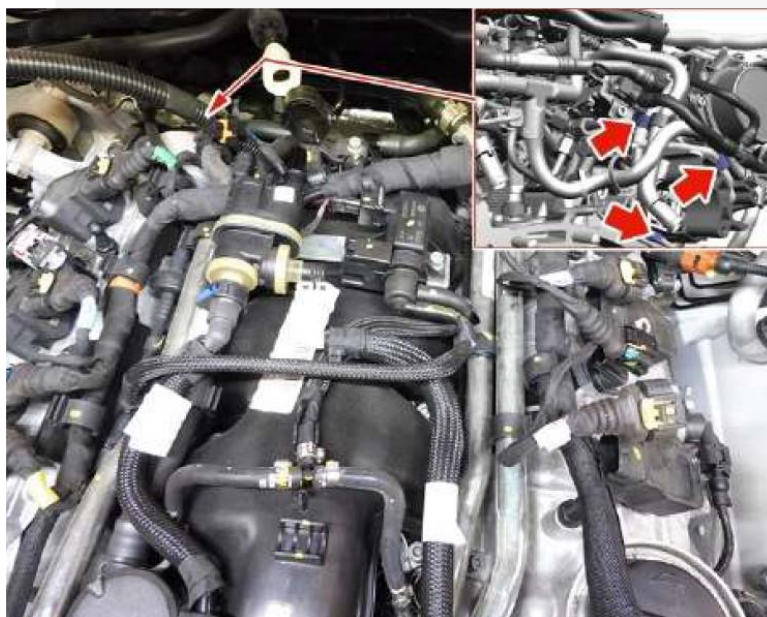
3. the procedure indicated in the workshop manual up to **step 22** (where you release the clips shown in the photo):

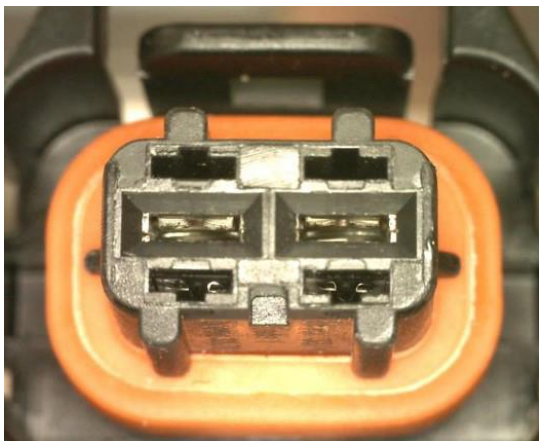
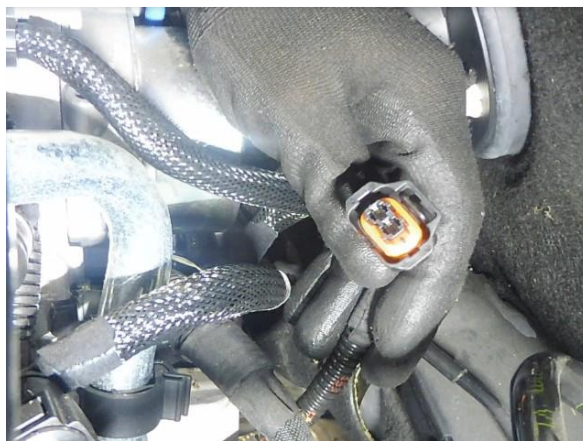
4. Identify the connector to allow correct procedure.

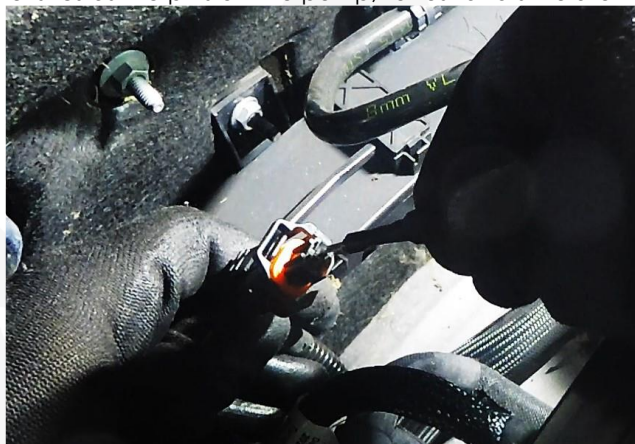
5. Insert the feeler (p/n 900100002) in one of the two seats of the connector. The feeler is designed to have the same dimensional characteristics as the pins on the pump, to test and simulate the coupling.

6. Wiggle test the connector manually, with the sensor inserted, to check that there is no looseness of the seat such as to allow the sensor itself to come out, partial or total (this is to simulate the vibrations of the vehicle during operating conditions).

10. If, on the other hand, the test is *negative*, i.e. the probe does not remain well connected even to only one of the two seats, the component is **NOT OK**. At this point the **connector** (p/n 673015820) needs to be **replaced**.

11. Replace the connector following the procedure indicated in the bulletin **MAS000766**. (For details, please refer to TechDOC procedure **0.30.005 - CONNECTORS REPAIR - REPLACEMENT - Warnings**).
