GENERAL MOTORS
DCS6889
URGENT - DISTRIBUTE IMMEDIATELY

Subject: N232434060 - Service Update
Power Tonneau Cover Motor

Models: 2022-2024 GMC HUMMER EV Pickup
Equipped with ACCESSORY-TONNEAU (RPO 5KM)

N232434060 Power Tonneau Cover Motor

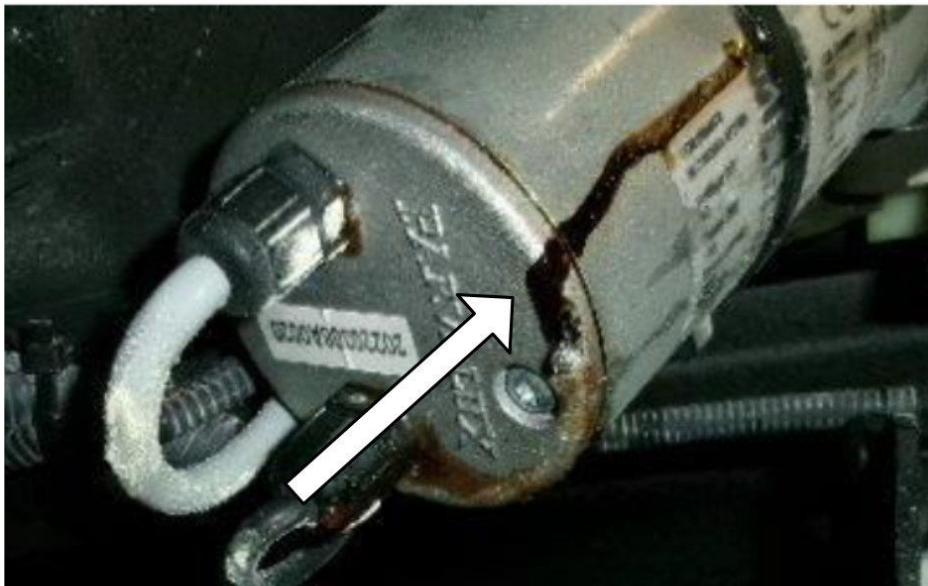
6579822

6. Inspect the Power Tonneau Cover Motor for damage such as leakage or any visible brown substance on the motor.
 - If the Power Tonneau Cover Motor IS NOT damaged, proceed to Step 11.
 - If the Power Tonneau Cover Motor IS damaged, proceed to Step 7.

Important: If the Power Tonneau Cover Motor is damaged, submit a photo of the damaged Motor in GWM when submitting the claim for this field action. FAILURE TO INCLUDE A PHOTO OF THE DAMAGED MOTOR MAY CAUSE CLAIM TO REJECT.
