Service Bulletin

Bulletin No.: 23-NA-123

Subject: LSY P30EF Cooling Fan Service Calibration

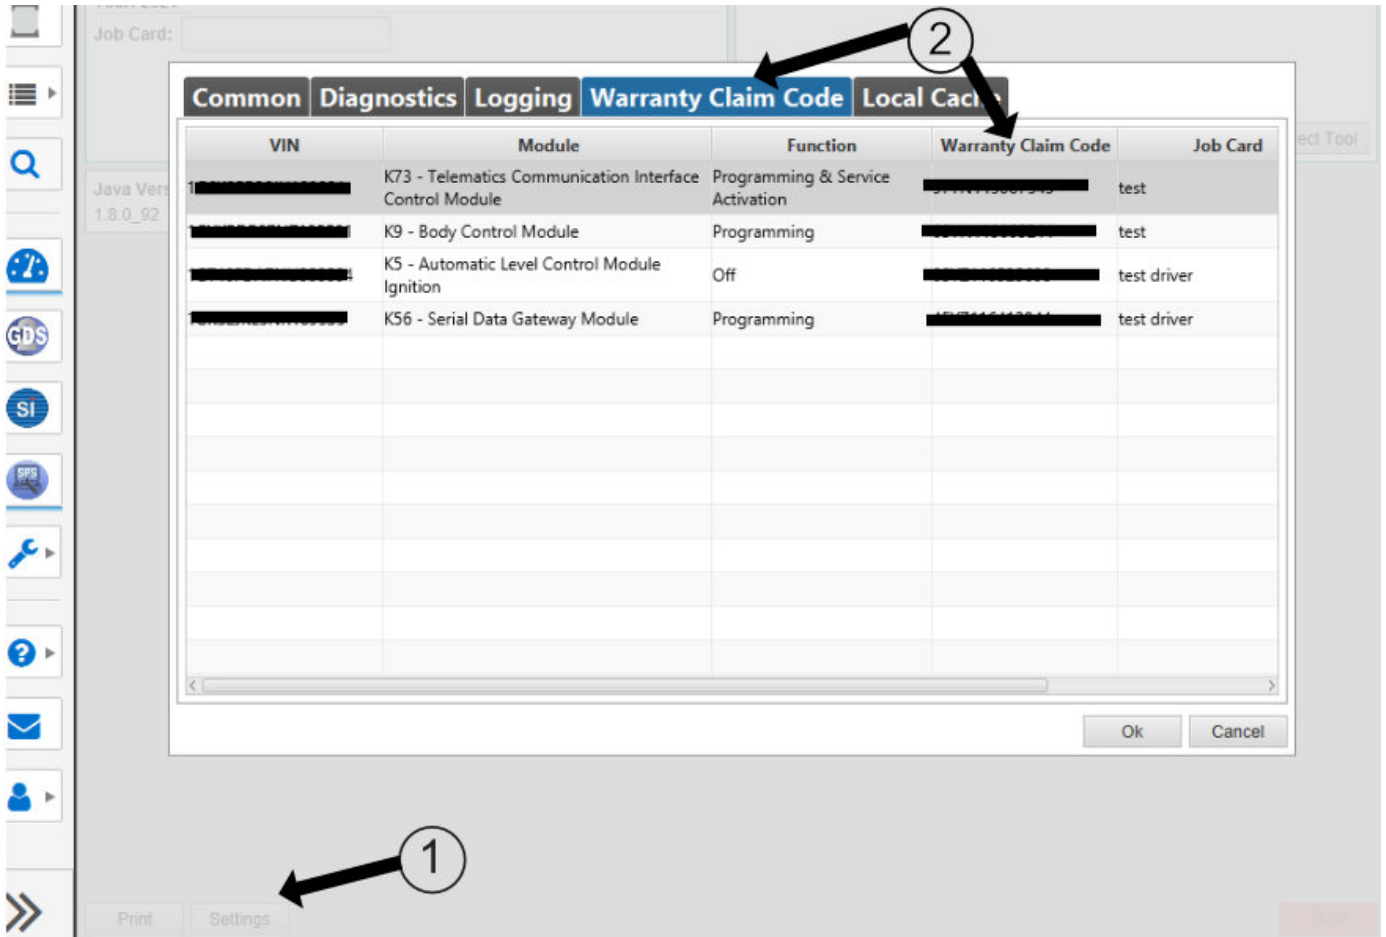
6125774

If the Warranty Claim Code was not recorded on the Job Card, the code can be retrieved in the SPS2 system as follows:

1. Open TLC on the computer used to program the vehicle.
2. Select and start SPS2.
3. Select Settings (1).

4. Select the Warranty Claim Code tab (2).

The VIN, Warranty Claim Code and Date/Time will be listed on a roster of recent programming events. If the code is retrievable, dealers should resubmit the transaction making sure to include the code in the SPS Warranty Claim Code field.
