SIB 11 07 23

**VOLUNTARY EMISSION RECALL 23E-A05: REPLACE SWITCHABLE  
ROCKER ARM**

This Service Information Bulletin (Revision 7) replaces SI B11 07 23 **dated February 2024**.

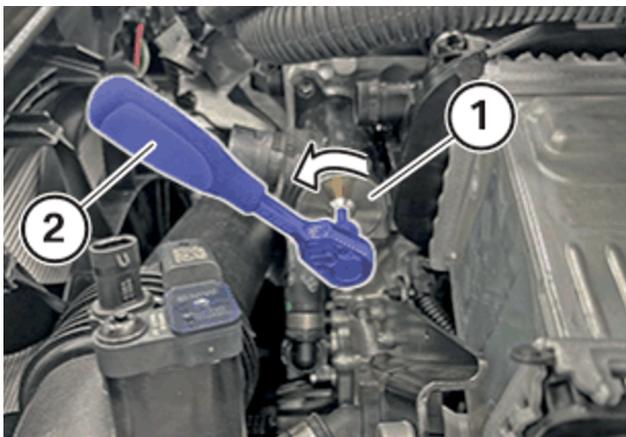
Cylinder 6 intermediate lever may interfere when trying to install the intake camshaft timing tools.

Place the variable valve timing (VVT) motor in minimum lift before installing the camshaft timing tools.

Use a 4 mm Allen socket (1) and a ratchet (2) to turn the VVT motor counter clockwise until it stops at the minimum lift end stop.

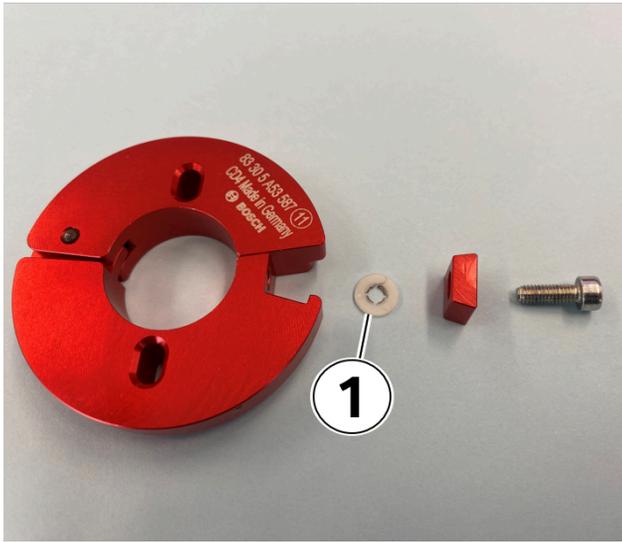
Tool 83 30 5 A53 587 may bind when removing it from both of the VANOS adjusters, the plastic washer (1) may be binding the tool and will not allow it to collapse when the screw is loosened.

Removing the washer entirely could result in the screw and wedge falling into the engine, the washer avoids loosening the screw too much.

Using a fine metal file, reduce the outside diameter of the plastic washer by approximately 1 mm to avoid this interference.

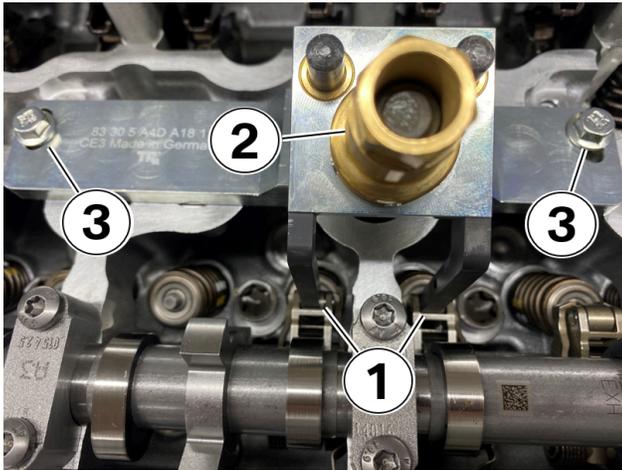
Special tool 83 30 5 A4D A18 must aligned properly with the rollers (1).

Turn the brass nut (2) to make contact with the rollers.

Tighten the screws on the base plate of the tool (3).

Finish compressing the springs with the brass nut (2).

The tool must remain installed during the entire camshaft removal and installation procedure.
