Service Bulletin

Bulletin No.: 24-NA-082

Subject: Clicking Noise at Slow Speeds

Brand:	Model:	Model Year:		VIN:		Engine:	Transmission:
		from	to	from	to		
Cadillac	LYRIQ	2023	2024	-	-	-	-

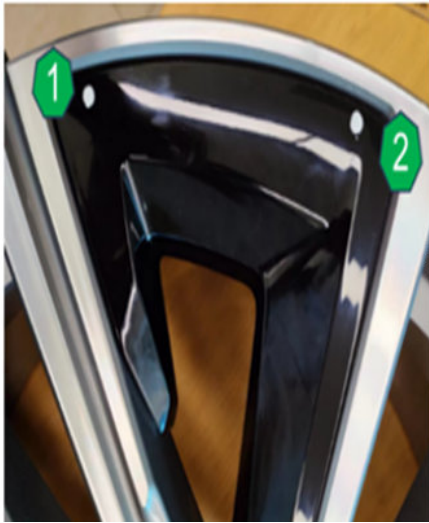
6465406

1. Place the wheel horizontally on work bench. Need to check 2 points (shown with white dots in above illustration) for each of the 6 inserts on the wheels.

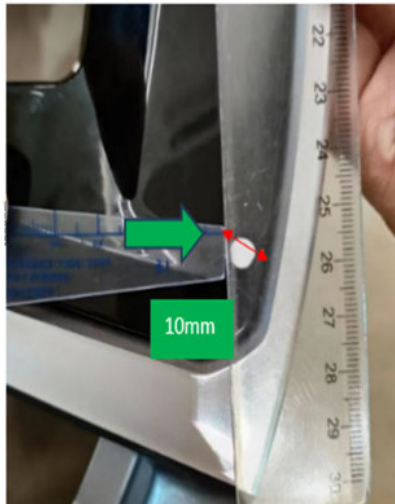
6465407

2. Place the flat bar on the front of the wheel from point 1, covering 10mm of the insert in the width.
3. Insert the 1.7mm feeler gauge between the flat bar and the insert.

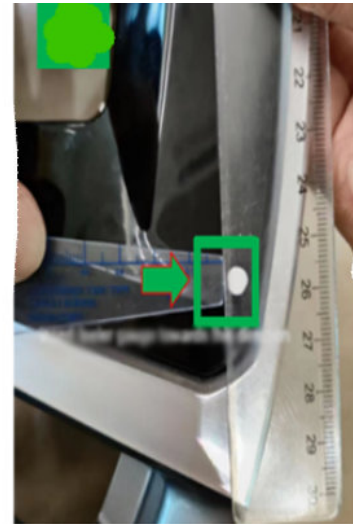
6465411

4. If the feeler gauge cannot go through the gap between the ruler and the gauge, the part is OK as shown above.

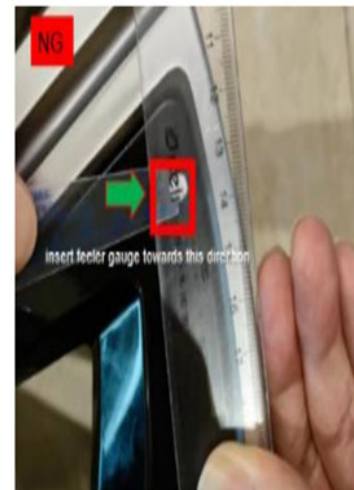
6465412

5. If the feeler gauge can go through the gap between the ruler and the gauge, it means the insert is sitting too deep.
6. Measure the two points (Point 1 and Point 2 as shown in Step 1).
7. Inspect the remaining five inserts following the same method.
