SIB 28 02 24

SERVICE ACTION: DOUBLE CLUTCH TRANSMISSION REWORK AT TRANSFER CASE

U11 (X1 Sports Activity Vehicle)	U10 (X2 Sports Activity Coupe)
----------------------------------	--------------------------------

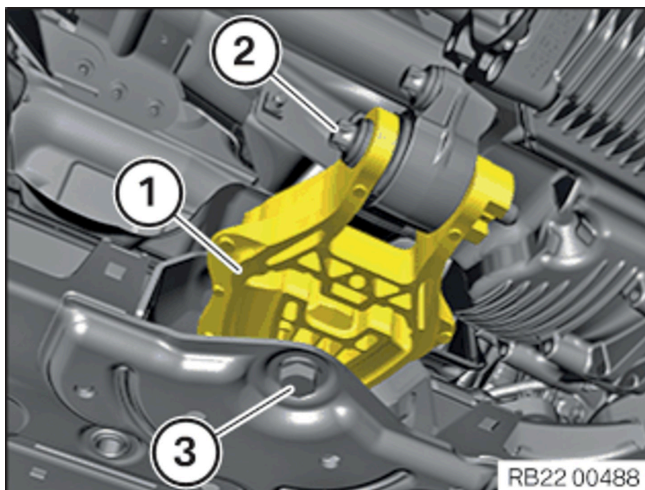
Remove the stabilizer link (1).

Reinstallation: Replace bolts 2 and 3

Tighten to 100 Nm and torque angle 90°

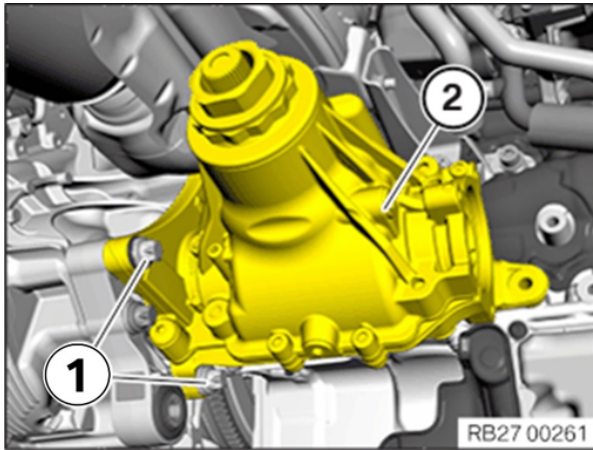
Remove the two bolts (1) on the transfer case.

Reinstallation: Replace both bolts

Tighten to 100 Nm and torque angle 90°

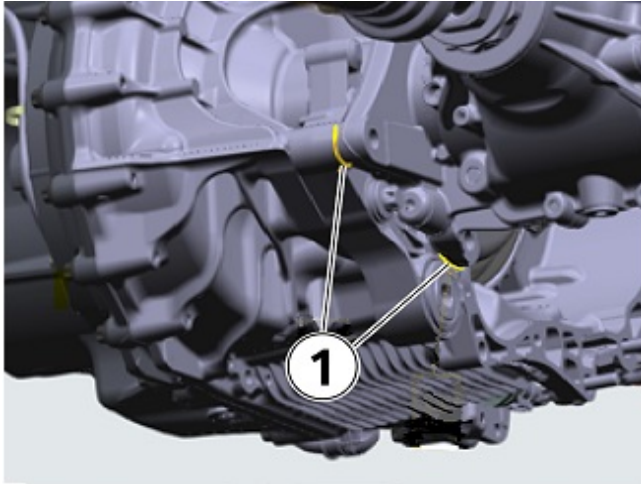
Micro-movements combined with frictional corrosion can increase wear on the longitudinal splined connection between the double clutch transmission (DCT) and the transfer box.

Install washers between the link and transfer case. It may be necessary to slightly push the transfer case to the side to install the washers.
