# Service Bulletin

XL750R #1

## PRODUCT UPDATE CAMPAIGN

### 2024 XL750R TRANSALP OWNER'S MANUAL MISSING QUICK SHIFTER INSTRUCTIONS

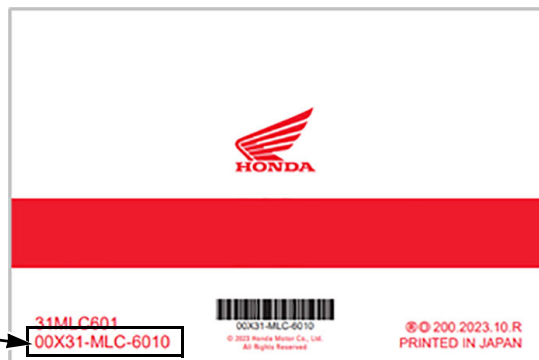
2024 TRANSALP Owner's Manual Rear Cover

Owner's Manual  
Part Number
