## NTG6 MBUX multimedia system: High-frequency interference noise from speakers or rattle sound from instrument panel area or interference noise from speakers while driving over bumps or uneven road surfaces

Topic number	LI82.85-P-069851
Version	3
Function group	82.85 - Navigation and Communication systems
Date	5/1/24
Validity	Model series167 with code 547/548/549+810
Reason for change	Extended title and solution

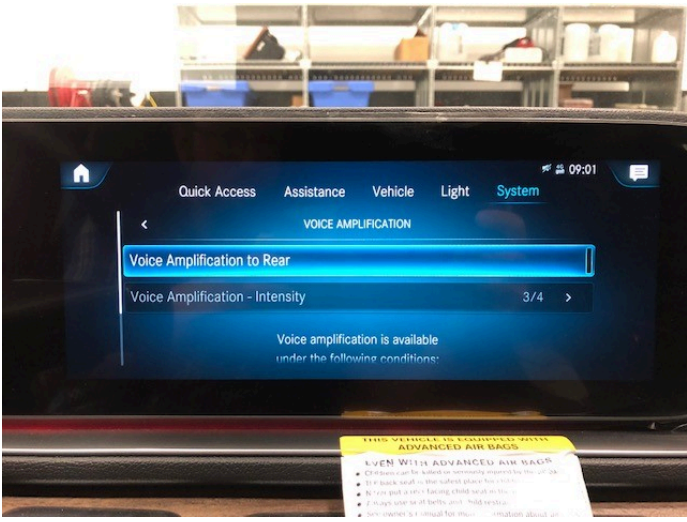
Voice amplification menu

High-frequency interference noise may be heard from the speakers while driving. This complaint only occurs when "voice amplification" is active.

Coupling noise of microphone signal in voice amplification.

The interference noise can be remedied by deactivating voice amplification: "Home" -> "Settings" -> "System" -> "Audio" and de-select "Voice amplification to rear" to switch off the function (see attachment).
