GROUP	MODEL
BOD	2024MY Sorento (MQ4a)
NUMBER	DATE
328	May 2024

## TECHNICAL SERVICE BULLETIN

### SERVICE ACTION: FRONT DOOR HANDLE ANTENNA REPLACEMENT (SA575)

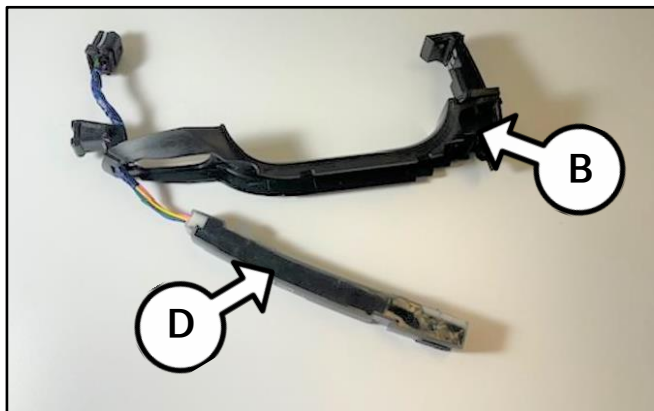
This bulletin provides information to replace both left and right front door outside handle antennas on certain 2024MY Sorento (MQ4a) vehicles produced from December 5, 2023 through February 12, 2024 equipped with capacitive touch/NFC type door handles. The affected vehicles may experience an inoperative capacitive touch handle caused by the antenna(s) not sensing the touch signal for locking/unlocking the door. Follow the procedure outlined in this publication to replace both left and right front door outside handle antennas on the applicable vehicle. Before conducting the procedure, verify that the vehicle is included in the list of affected VINs.

- 4a. To separate the antenna assembly (D) from the door handle grip (B), pull the two pieces apart.
- 4b. Install new antenna assembly (D).
