Service Bulletin

Bulletin No.: 22-NA-173

Subject: Information on Transmission Fluid Leak

Brand:	Model:	Model Year:		VIN:		Engine:	Transmission:
		from	to	from	to		
Chevrolet	Corvette	2020	2024	—	—	All	All

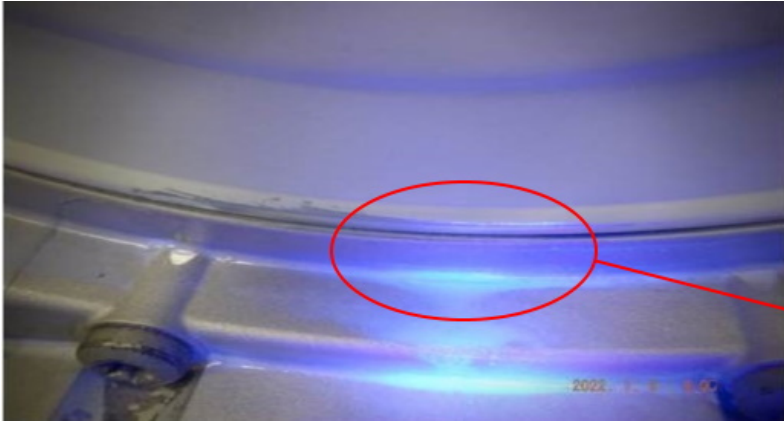
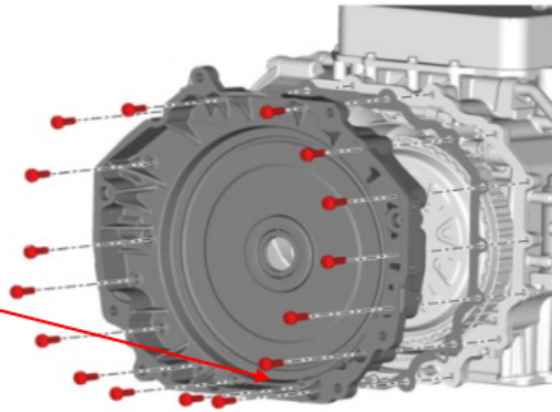
6142752

A leak between sealing plate and Bell Housing.

- If this leak is found, it will be necessary to replace the clutch differential housing assembly. Be sure to

also order all the one-time use parts in the service information repair instructions.

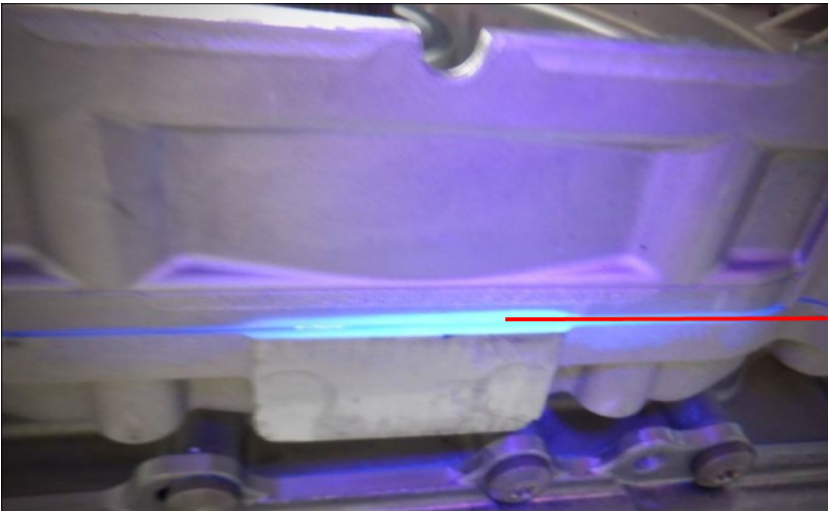
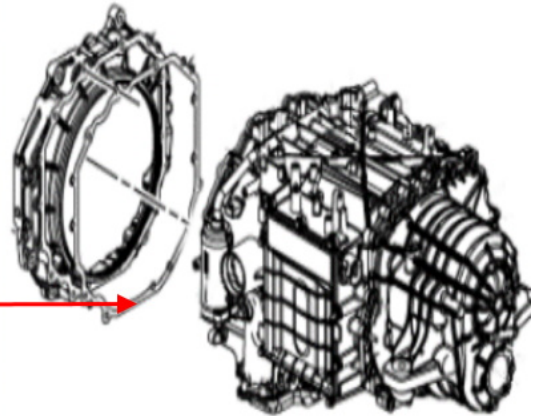
6142966

Leaks at the gasket area between the clutch and differential cover and the main case. There is a gasket in this area.

- The gasket in this area is serviceable. Be sure to follow service information for which parts are one-time use and order these components. Also be sure to inspect the machined surfaces and attempt to verify that the leak is actually caused by the gasket rather than a bolt torque or surface finish issue that may cause a duplicate repair.

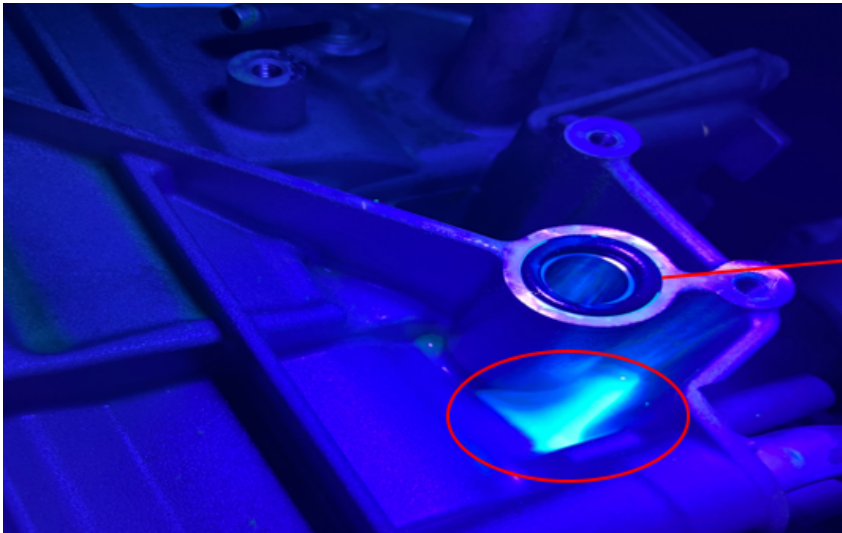
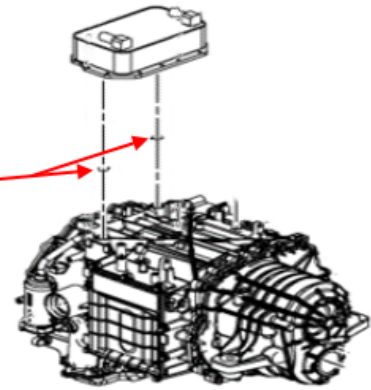
This is an area that is often mis-diagnosed as a transmission cooler issue. It was found that in most cases, leaks in this area are caused by transmission case porosity under the transmission cooler. Proper diagnosis in this area would be to inspect the cooler for any signs of physical damage. If no damage is found, carefully remove the cooler, and inspect the two (14) O-rings for damage and proper sealing. The dye photo shows a puddle of oil just under the cooler sealing

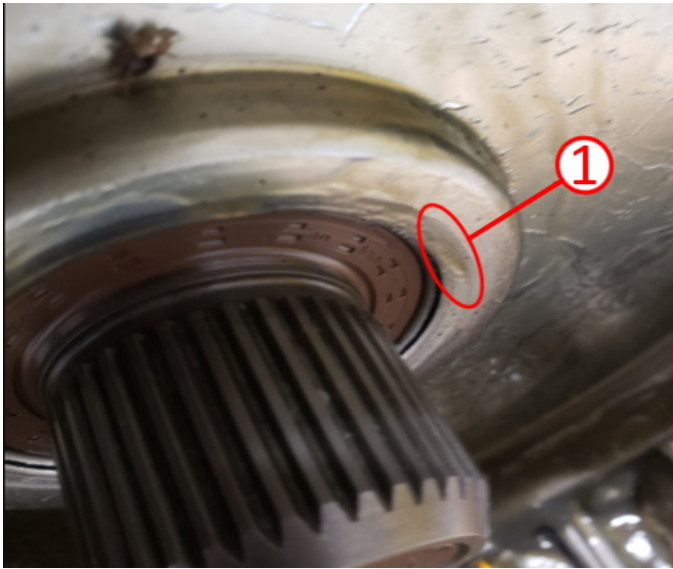
A small crack in the clutch cover area (1) of the input shaft seal can be mis-diagnosed as an input shaft seal leak (3). Additional cases have been verified at the input shaft end plug/seal (2), was damaged during transmission to engine mating. The input shaft end plug and the input shaft seal can be serviced separately if a crack is not witnessed in the clutch cover. If the area is cracked the clutch differential housing assembly will need replacement as an assembly. The input shaft end plug does not come with the clutch differential cover assembly.

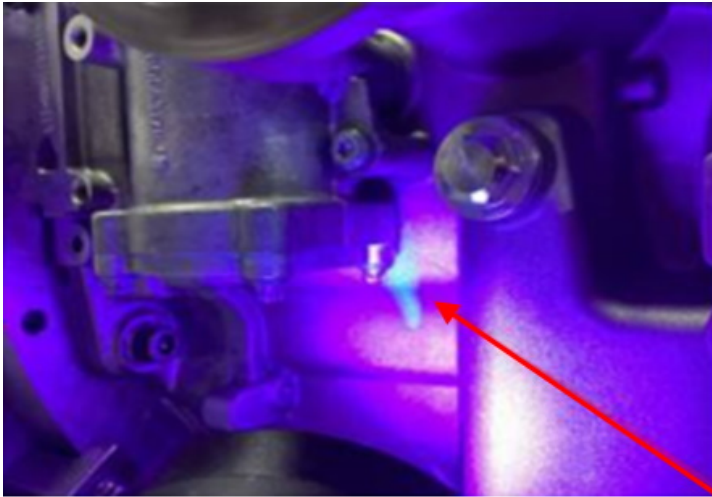
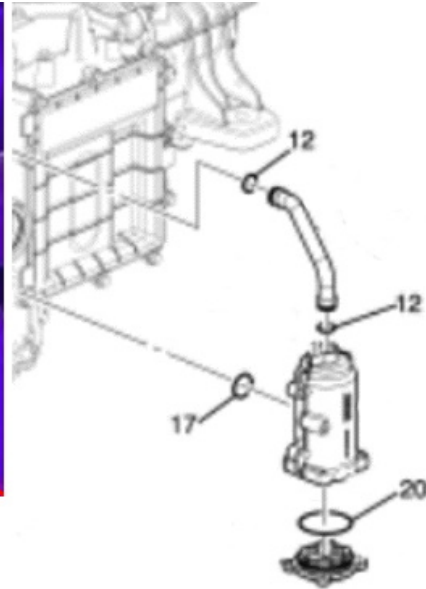
6142744

The auxiliary canister filter can create leaks in several areas. The most common area is cover seal (20), O-ring installation issues after filter replacement. Other areas of concern can be found at the are O-rings (12) and (17).

The photo above shows the red arrow pointing to a case porosity issue that was found lying behind the auxiliary canister housing. With any case porosity issue, the transmission will require replacement. The photo below shows the red arrow pointing to the auxiliary canister filter cover O-ring groove. There have been known cases with porosity found in the O-ring groove causing leaks in this area.

Note: Inspect the cover prior to replacement of the seal for porosity issues in the O-ring groove area.

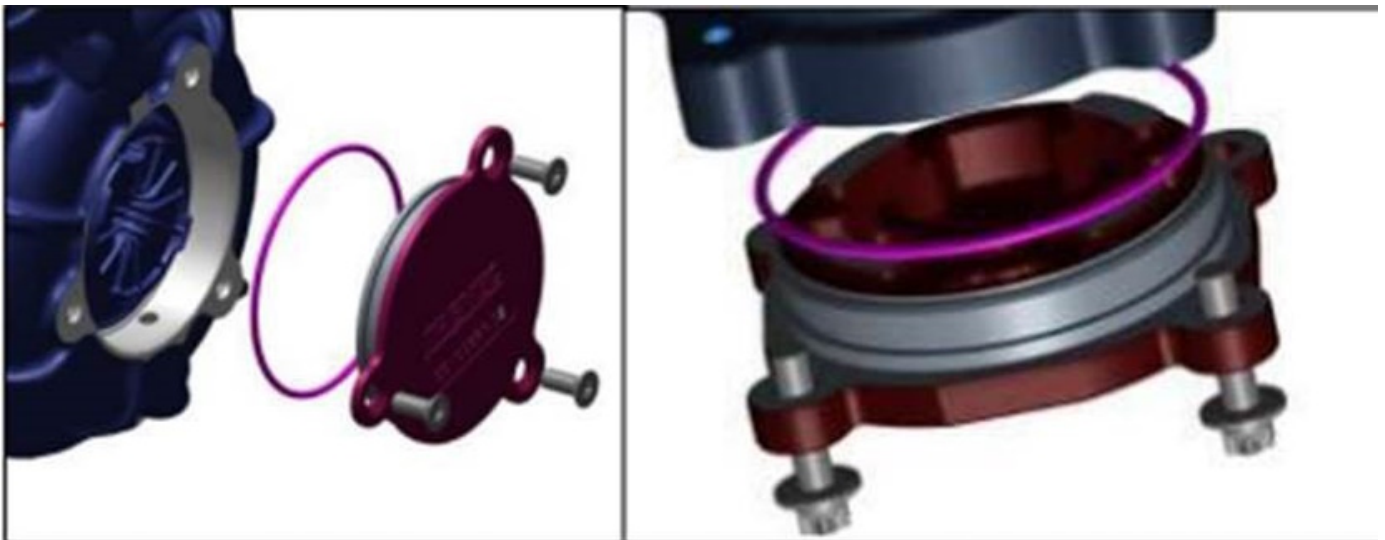
6456550

Transmission rear cover area leak. (Tremec name plate):

- The red arrow in the graphic above, points to the oil dam that may come off when the cover (Tremec name plate) is removed. If it is removed, it is necessary to replace the associated O-ring and align properly with cover prior to re-assembly. Damage will occur if the oil dam is not aligned to match the cover.

- If there seems to be a leak in this area, be sure to clean the area thoroughly. Residual oil can get trapped between the outer surface and the O-ring.
- After powder testing, if a leak re-occurs, remove the cover, and inspect the O-ring for damage.
- If no obvious damage is found with the O-ring, be sure to inspect the cover itself for porosity issues in the O-ring groove. It is critical to identify the difference between a leak and dampness.

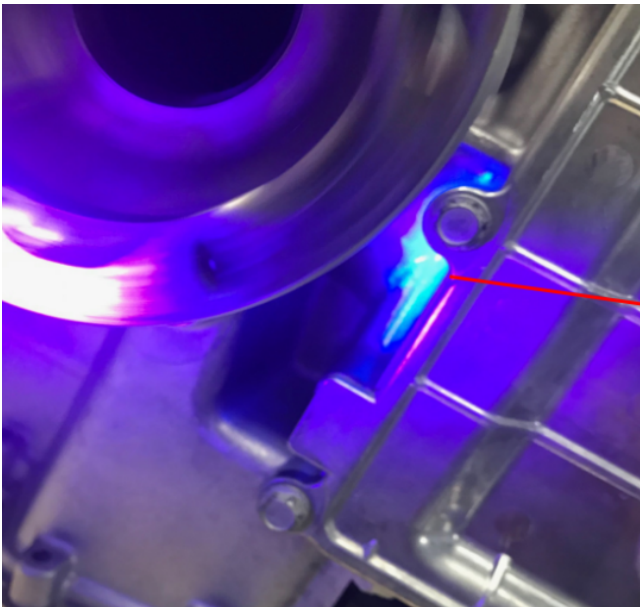
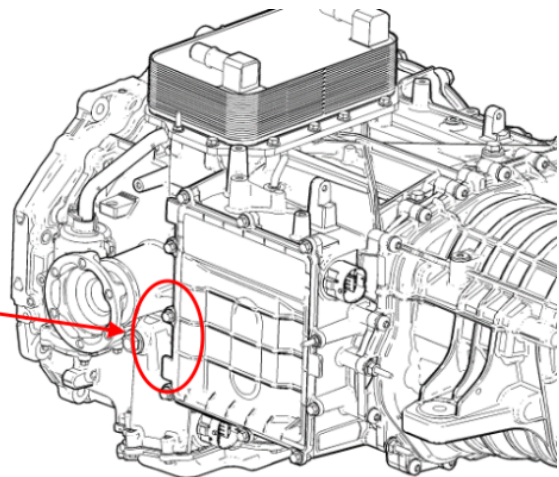
6142979

Transmission case porosity concerns have been found in the SAV cover area of the transmission. This is often the most misdiagnosed leak on this transmission. The fluid seeps through the case and runs down between the SAV cover and case to the pan rail, and often the transmission pan, and gasket get replaced, then the SAV cover, and finally the transmission. Often

these leaks will not develop by just allowing the engine to run. Usually, the vehicle will need to be lifted safely on a hoist with the wheels raised to allow the vehicle to run in gear. This action applies to most porosity leaks.

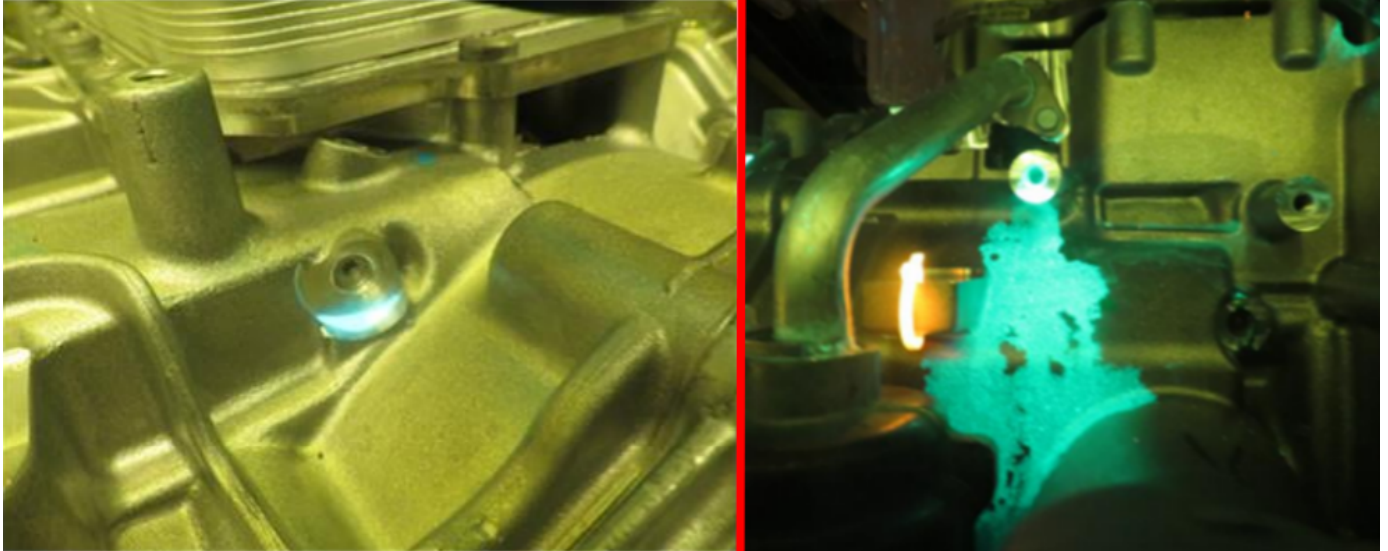
6636539

Plug leakage and fluid leaking from blind holes will require transmission replacement.

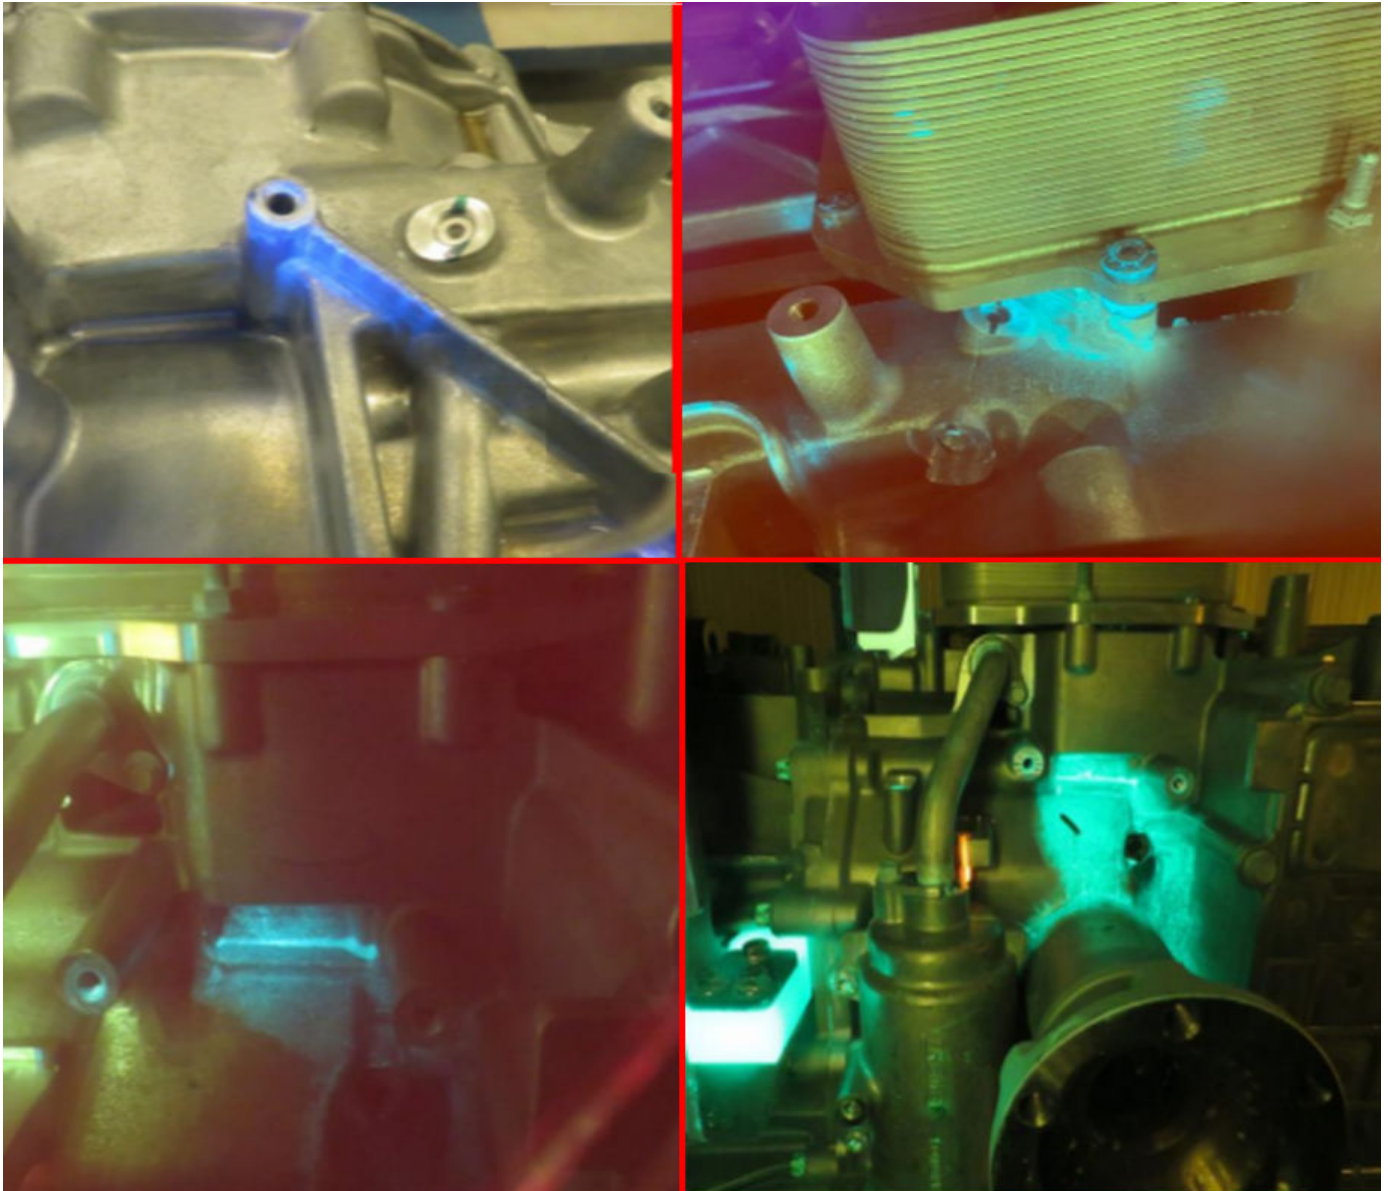
6636536

Examples of case porosity in front of the SAV cover and above that left axle stub that may present as an axle seal leak of SAV cover leak. Powder testing should allow identification by the technician. If leak is

porosity in these areas the transmission assembly will need replacement.

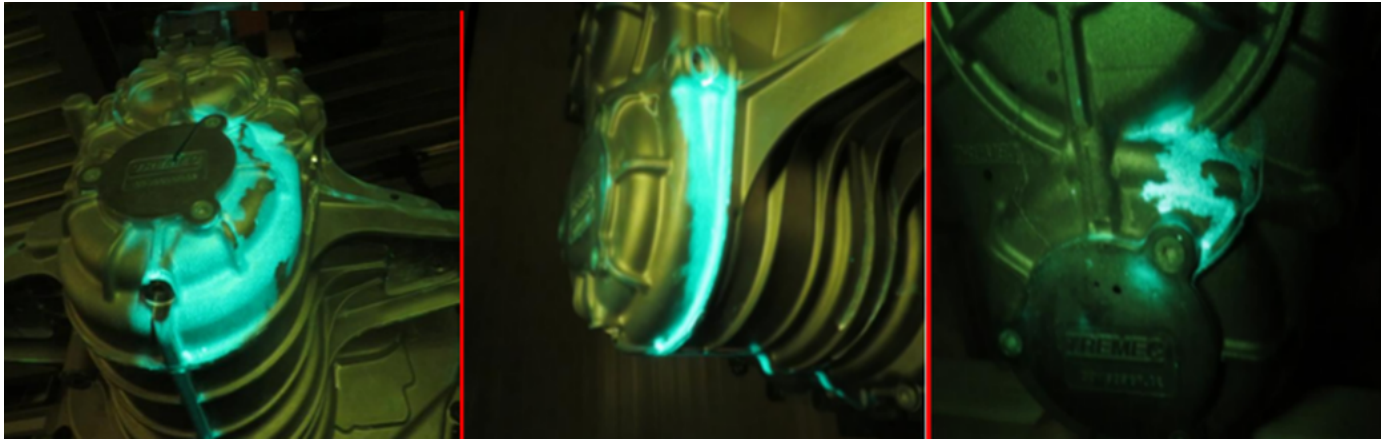
6636545

The graphics represent new areas that may exhibit porosity. The last photos show the difference between rear case porosity and rear cover (Tremec nameplate) leaks.
