SIB 46 03 24

SERVICE ACTION: Replace Front Panel Carrier Screws

Model	Model Description	Model Code
K81	F 900 GS	0K63

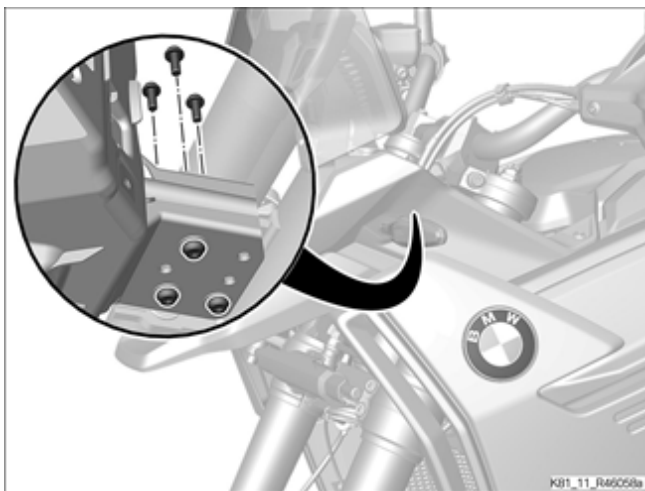
After quality inspection BMW Motorrad has found that the front panel carrier bolting was not tightened properly during installation at the factory. As a result, there may be a rattling noise or vibration in the cockpit area over time.

The 6 micro-encapsulated screws must be replaced and tightened to 10 Nm.

This can be done without removing any parts when the handlebars are turned fully to either the left or right lock.

Clean the threads before installing the new screws.

Note: If the Genuine BMW Motorrad optional accessory, additional headlight: then only the 2 remaining original screws (top left and right) need to be replaced. Because the additional headlight replaced 4 of the other screws once installed.
