## SIB 63 01 24 SERVICE SOLUTION: Headlight Misted Over

2024-05-07

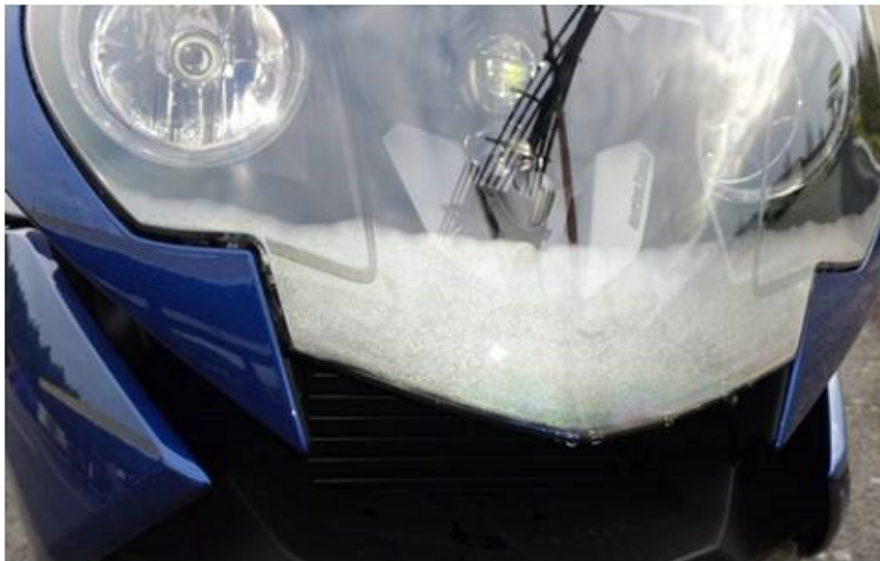
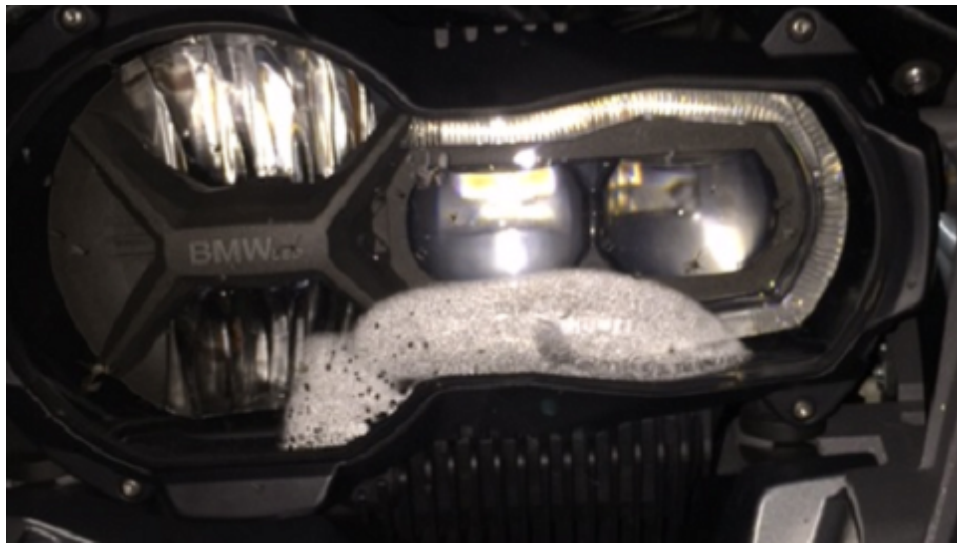
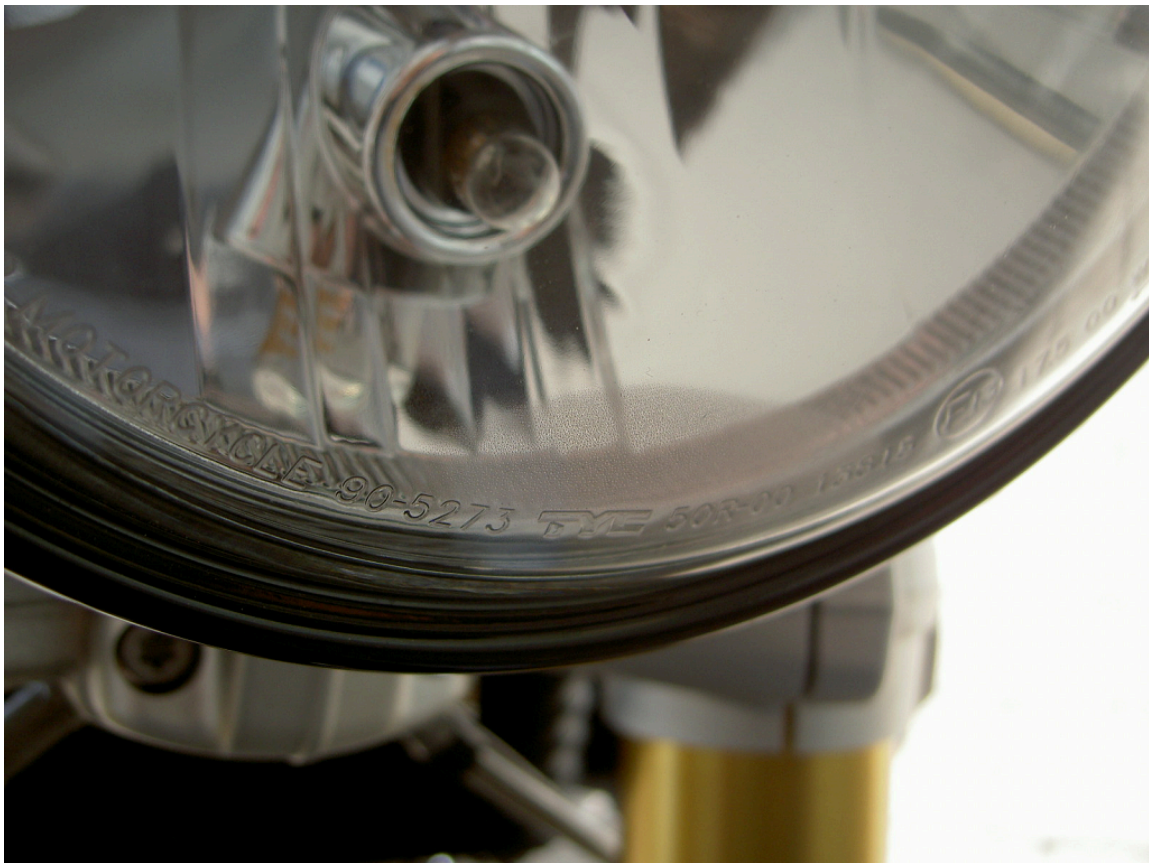
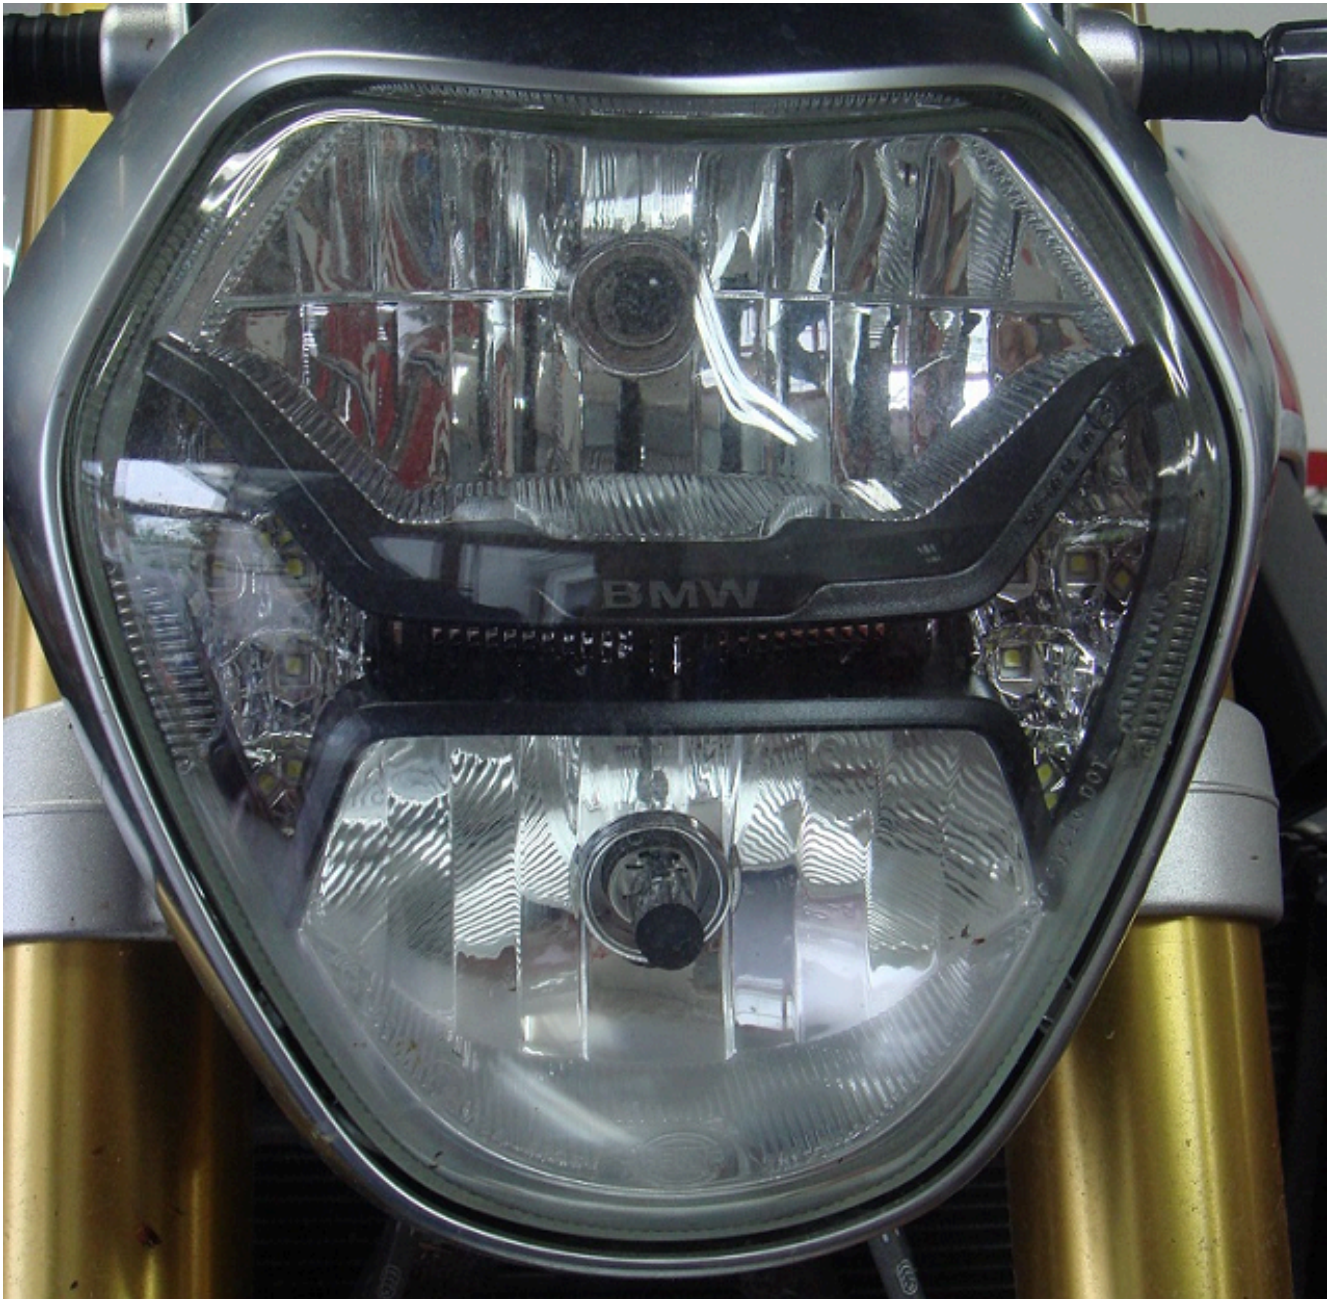
Examples:

Headlight is misted over.

Headlights are vented to the atmosphere this means they have openings for air to flow through. Because of this the headlights are not waterproof.

Mist is the result of condensation forming on cooler surfaces.

For mist or condensation to form; the air temp, humidity, air pressure and surface temp of the headlight diffuser must meet specific criteria.

Dealer must explain the reasons and causes of the mist or condensation to form to the customer.

Note: the mist disappears while driving under specific conditions after roughly 15 miles of riding at approximately 60 mph.

In case of any doubt, create a TSARA case with photos of the misted headlight.
