M254 Engine oil seeping from timing case cover

| Topic number | LI01.60-P-077807 |
| Function group | 01.60 - Timing case |
| Validity | Model year 2022 Model 206 with M254 engine |

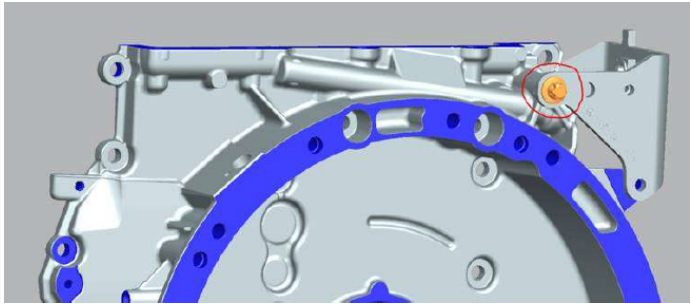
| Attachments | |
|---|---|
| <a href="#">Leakage location.PNG</a> | |

Engine oil seeping from right rear of engine at upper area of timing case cover.

Porosity in casting of timing case cover.

Clean area around exhaust bracket and apply leak detection spray. Proceed with below steps if leakage is confirmed from orange bolt shown in attachment.

- Remove orange bolt shown in attachment and thoroughly clean bore with brake cleaner.
- Ensure bore is completely dry.
- Use new bolt N000000007063 and coat threads with Loctite 222.
- Install bolt and torque to 20 Nm.
- Allow at least 12 hours before starting engine. Then recheck for leakage.
