GENERAL MOTORS  
DCS6907  
URGENT - DISTRIBUTE IMMEDIATELY

Subject: REVISION: N232426401-02 Customer Satisfaction Program  
Disabled Liftgate Exterior Release Switch Assembly Replacement  
Service Part Inspection Added

Models: 2020-2024 Chevrolet Silverado 2500 HD/3500 HD  
2020-2024 GMC Sierra 2500 HD/3500 HD  
Equipped with GATE FUNCTION-MANUAL ASSIST POWER  
RELEASE (RPO QT5)

## N232426401 Disabled Liftgate Exterior Release Switch Assembly Replacement

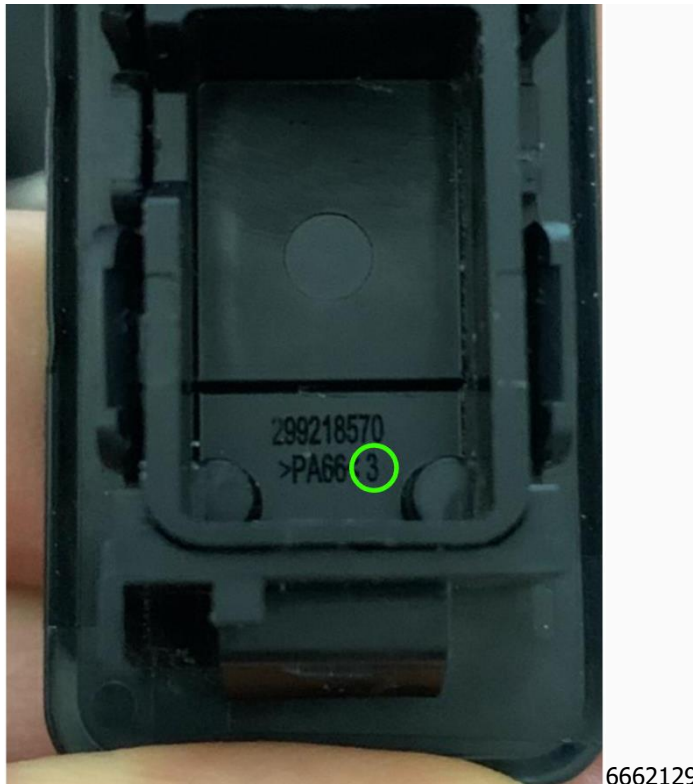
- Inspect the number shown on the replacement switch.
  - If the last digit is “1”, the part is BAD and MUST be scrapped.
  - If the last digit is anything other than “1”, the part is good and can be installed in the vehicle.

**IMPORTANT: BEFORE INSTALLATION, YOU MUST INSPECT THE PART PER INSTRUCTIONS BELOW.**
