Technical Service Bulletin

Subject: FUEL-FILLER LID CANNOT BE LOCKED AFTER AUTO-LOCK TIME HAS EXPIRED	Bulletin No.: 09-027/24
	Last Issued : 05/13/2024

2019-2024 Mazda3 5HB (Japan built)

2020-2024 CX-30 (Mexico built)

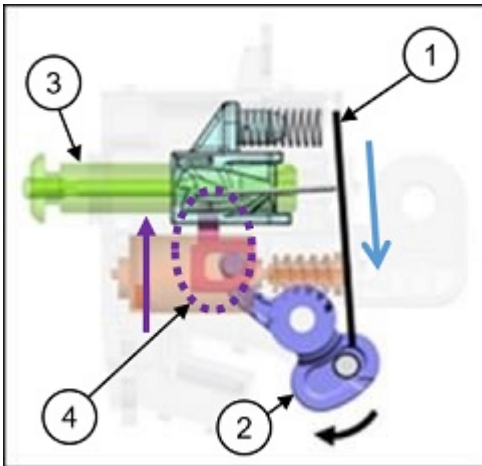
Inside of Fuel-Filler Lid Lock Actuator

TIP: By pushing the opener cable (1), the lock connected to the opener lever (2) inserts into the cam hole and the actuator rod (3) is locked.
