Service Alert

Subject: MAZDA CONNECT INTERMITTENT AUDIO NO SOUND AND/OR STATIC NOISE FROM SPEAKERS	Service Alert No.: SA-021/24
	Last Issued : 05/06/2024

2020-2024 CX-30
2019-2024 Mazda3

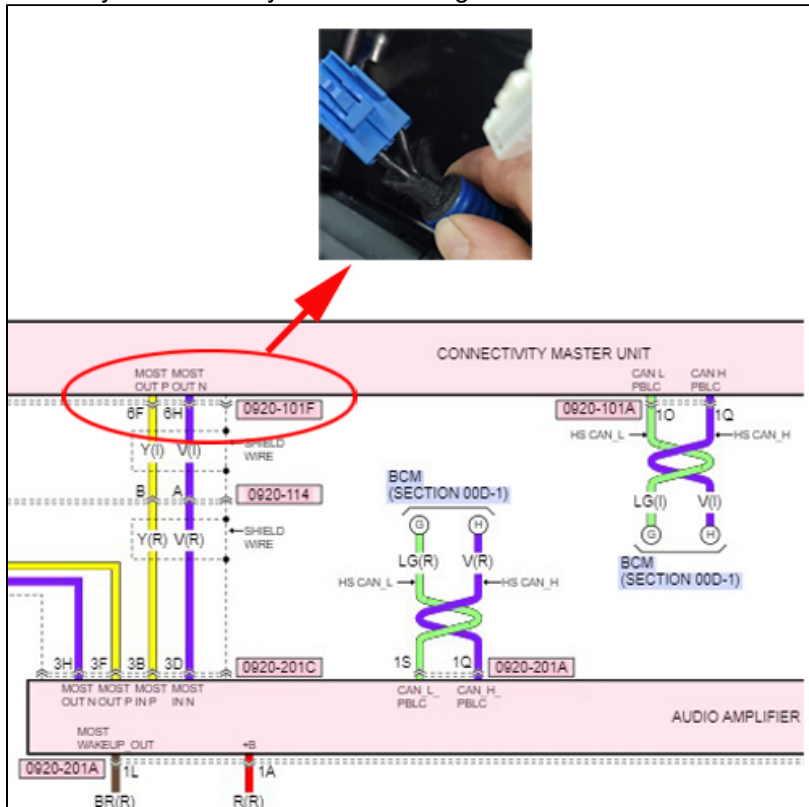
This may be caused by PIN 6F backing out at the CMU connector 0920-101F.
