Subject: ACCESSORY PADDED CARGO LINER INSTALLATION UPDATE	Service Alert No.: SA-033/24
	Last Issued : 05/29/2024

2025 CX-70

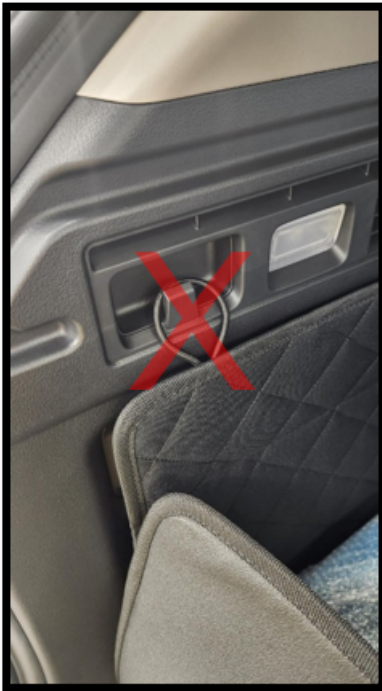
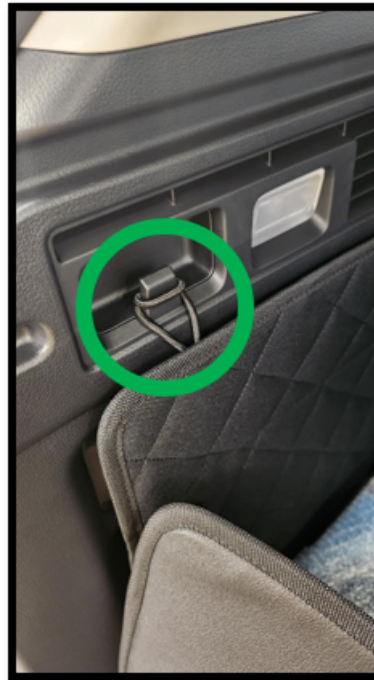
Due to variance in production, early production parts of the padded cargo liner may have long bungies for the side trim pieces. This condition may result in a loose fit around the cargo hooks. If this condition is observed, twist and wrap the bungee loop over the rear cargo hook for both LH and RH side panels for a tighter fit.
