Volvo Car USA LLC

Technical Journal

Technical Journal Title SiriusXM not Available		Ref. No. TJ 36771.1.3	
Issuer (Dept.) Technical Service		Issue Date 5/23/24	Status Date 5/29/24
Car Market United States and Canada	Partner 3 US 7510 Volvo Car USA	Function Group 3957	
Function Description Radio Tuner Module		Page Page 1 of 4

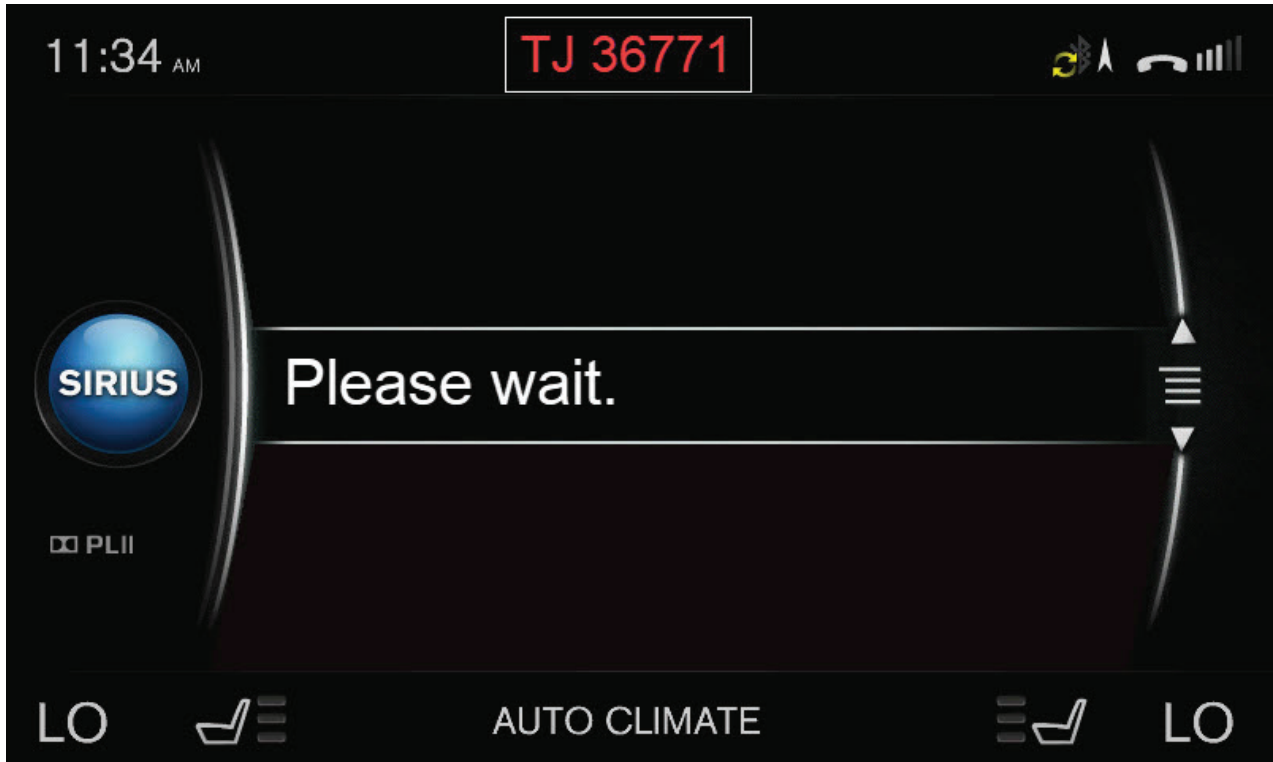
- 1) Verify the condition:
 - At startup, the Sirius screen will initially say "Please wait." (attachment TJ36771_1)
 - After several moments, the screen will say "Sirius unavailable" (attachment TJ36771_2)
 - In the SiriusID menu/screen, the Sirius ID will be blank (attachment TJ36771_3)
- 2) In the VIDA *Network* screen, check if the RDAR is *Not Responding*. If it is, power down the unit by removing RDAR (16/145) connector "C1" OR by removing fuse F1 (40 Amp) from the passenger compartment fuse panel (15/36) for 5+ minutes to recover it before proceeding.
- 3) Perform an update of the RDAR (Sirius Tuner Module) by downloading an RDAR upgrade with VIDA.

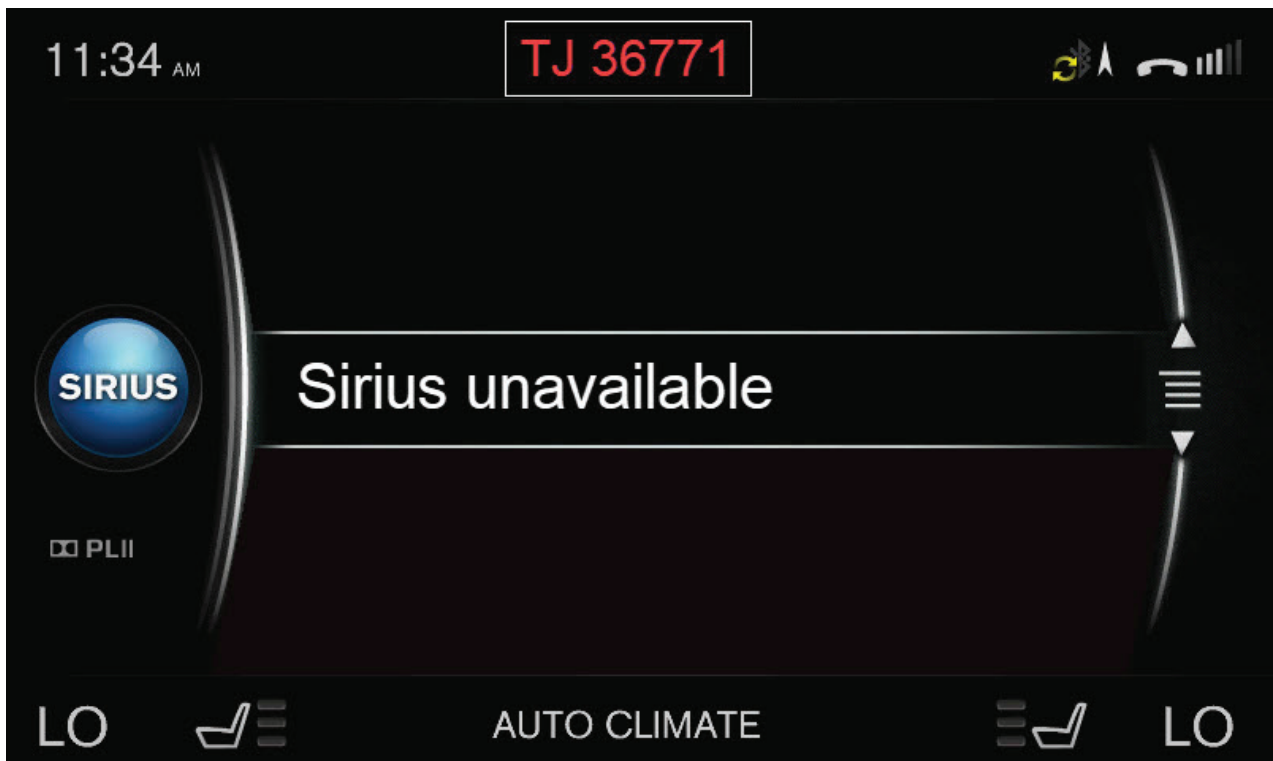
If the customer complains that their car is not receiving SiriusXM radio correctly and constantly showing a "Sirius Unavailable" message, please follow advice under "Service".
