MC20 – DTC 81151B, 81141B

DATE: May 24, 2024

CONCERN: Airbag warning light on and storage in ORC of DTC 81151B Right curtain airbag - circuit resistance over the threshold or 81141B Left curtain airbag - circuit resistance over the threshold

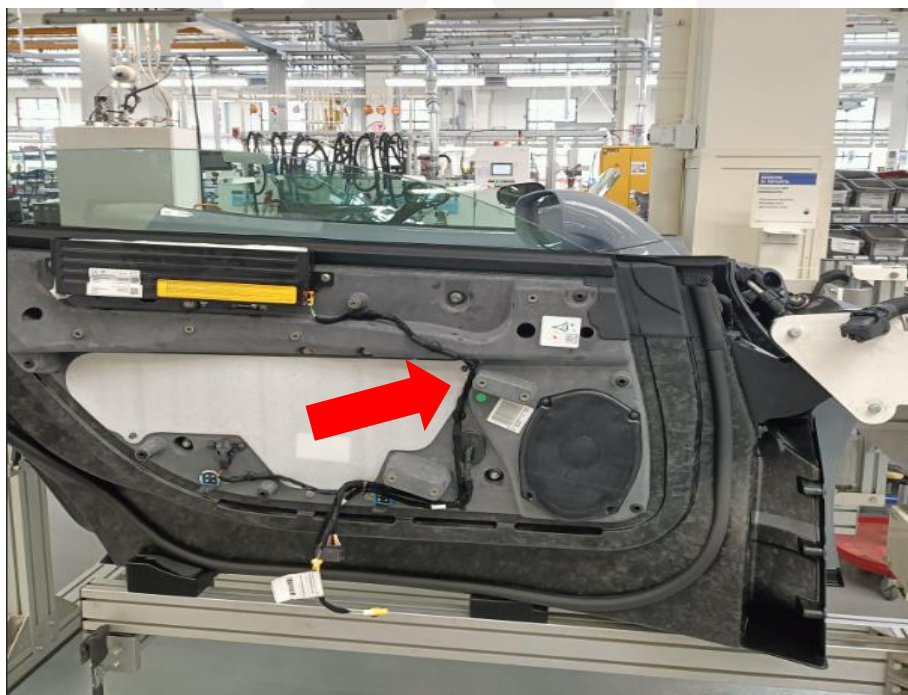
ACTION: To allow correct diagnosis and repair, please note that starting from assembly date of September 22nd, 2022 (Chassis 409912) the connecting bridles of the right and left curtain airbags are no longer integrated into the door panel wiring but provided as a separate component (Component #14 in table 08.60 - 2 MAIN WIRINGS).

This modification avoids any accidental tensioning of the harness when removing the door panel.

Due to this modification, the door panel wiring is no longer involved in the circuit and does not need to be diagnosed and/or replaced.

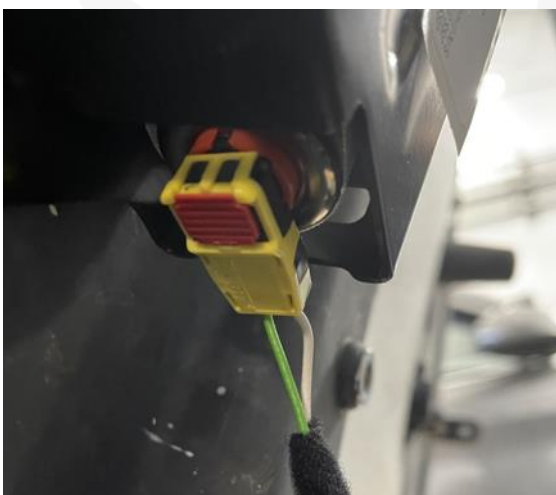
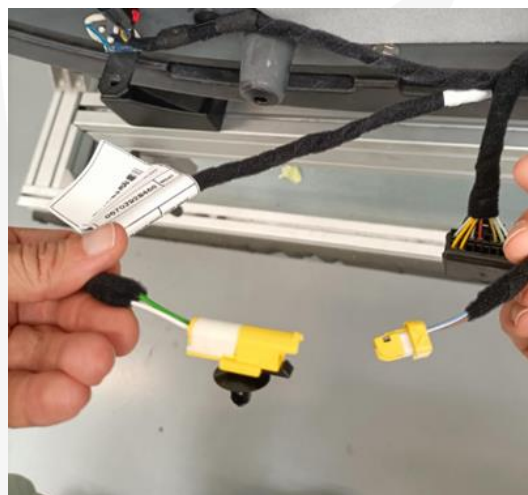
- 1) Save a scan report parameter + DTC of the ORC and check the resistance of the airbag circuit relating to the DTC. The resistance specification is 3 Ohms
- 2) Disconnect the 12V Battery (after, wait 5min)
- 3) Remove the door panel and visually inspect the wiring, without disconnecting the electrical connections of the curtain airbag and the Door Panel Bridle and the related wiring. Take pictures of the relevant connections and any anomalies found on the wiring
- 4) Gently move (wiggle test) one at a time first the curtain airbag connector and then the one connecting the door panel bridle and the door wiring. After each single movement, reconnect the battery and save the ORC parameters + DTC report again, paying attention to check whether the resistance value of the circuit has changed

- 5) Disconnect the battery again and inspect by disconnecting the curtain airbag connections and the relative intermediate connection between the door panel bridle and the door wiring.
