# TECHNICAL SERVICE BULLETIN

## 1.5L - Hissing Noise From Rear Liftgate Area When Driving Straight Between 35-50 MPH (56-80 Km/H)

24-2127

<b>Ford</b>	Engine: 1.5L
2021-2024 Bronco Sport	Built on 24-Jul-2021 and through 14-Dec-2023

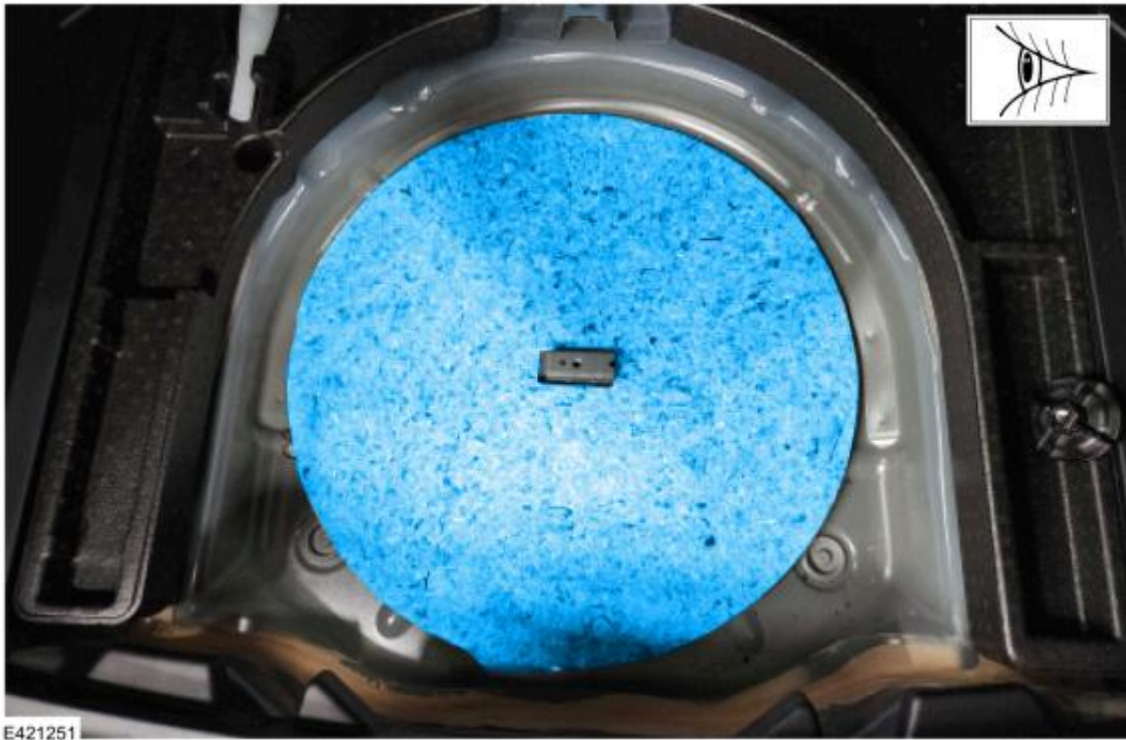
Figure 3

**Issue:** Some 2021-2024 Bronco Sport vehicles equipped with a 1.5L engine built on 24-Jul-2021 and through 14-Dec-2023 may exhibit a hissing noise from rear liftgate area when driving straight between 35-50 mph (56–80 km/h). This may be due to the absence of the rear floor insulator located in the spare tire compartment. To correct this condition, follow the Service Procedure to install a rear floor insulator in the spare tire compartment.

6. Install the rear floor insulator. (Figure 3)
