Technical product information

Bentayga Series

Fatigue warning is not visible within the Infotainment screen menu after the Data bus control unit (J533) was replaced

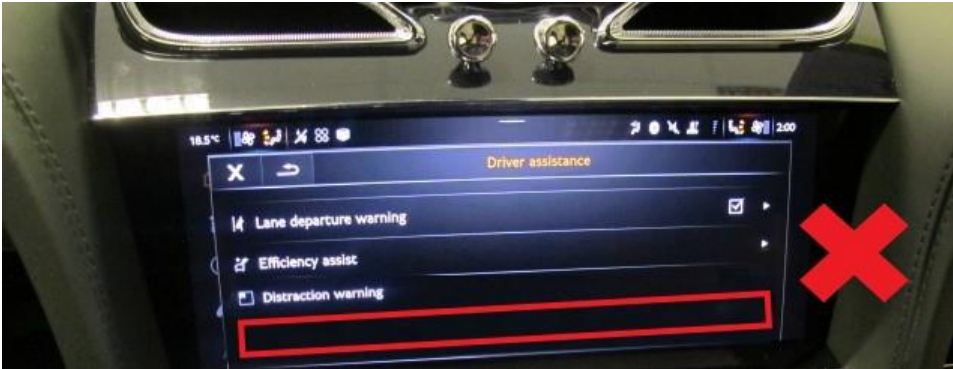
Fatigue warning is not visible (Figure 1) within the Infotainment screen menu after replacement of the Data bus control unit (J533)

When initialising and calibrating the replacement Data bus control unit (J533) one of the adaption channels may not have been written correctly. As a result, the menu entry for the fatigue warning in the Infotainment screen is missing

After initialising the Data bus control unit (J533) the operative must perform the configuration again as follows:

- Connect a suitable 12 volt battery charger to the vehicle before proceeding - Refer to Rep.Gr 27
- Select Guided functions from 0019 Data Bus OBD interface (Gateway) Control module (Figure 3)

Referring to Figure 4 - Select 0019 - Check control unit configuration > Select Run

- Once the procedure is complete check the infotainment screen to confirm if the "Fatigue warning" menu entry is displayed and can be selected under the Driver assistance menu as Figure 1

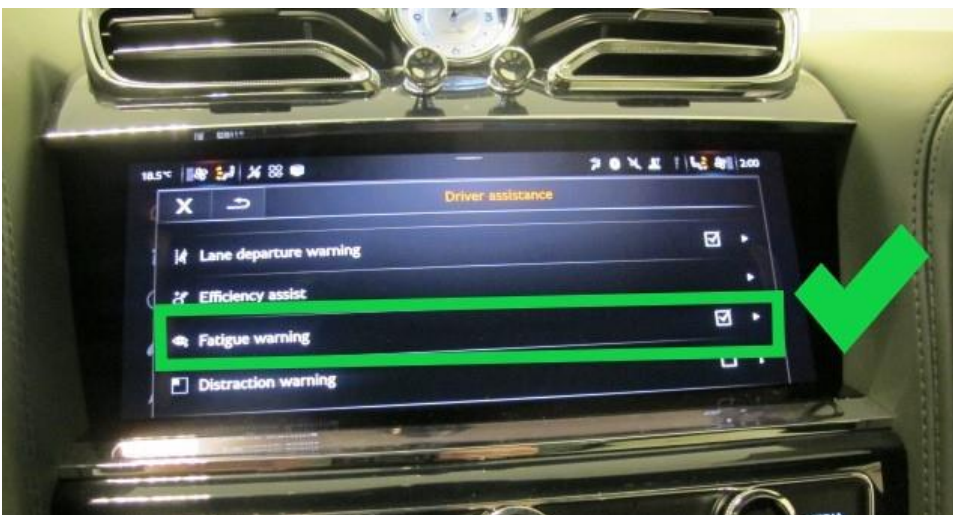
NOTICE
 Figure 2 shows the Fatigue warning (Correct status)
