# Technical product information

| Topic | New Flying Spur (Hybrid) and Bentayga (Hybrid) - DTC P019100: Fuel Rail Pressure Sensor "A" Circuit Range/Performance |

## New Flying Spur (Hybrid) and Bentayga (Hybrid) - DTC P019100: Fuel Rail Pressure Sensor "A" Circuit Range/Performance

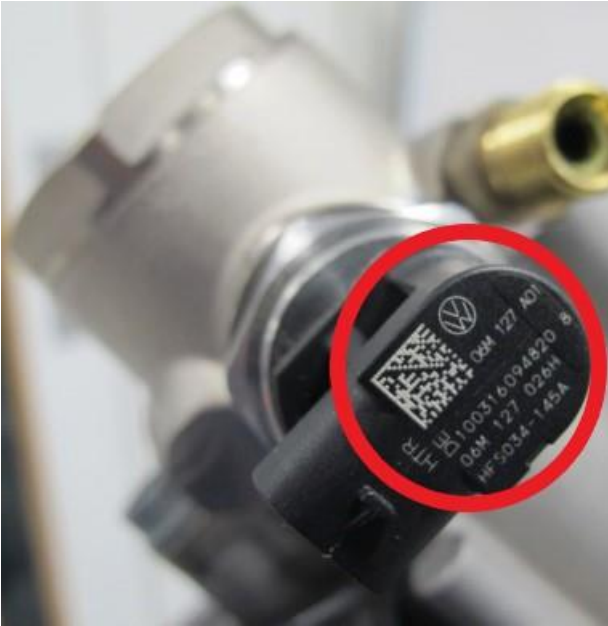
Hint: For clarity and photographic purposes Figure 2 shows the fuel pipe removed from the high pressure pump, please note the fuel pipe or high pressure fuel pump must not be removed unless instructed via DISS

- Clear photograph of the original high pressure fuel pump identification data (see the example in Figure 2)

- Await feedback before conducting any further work
