Technical Service Bulletin

Mazda North American Operations
Irvine, CA 92618-2922

Subject: AMBIENT TEMPERATURE IS DISPLAYED LOWER THAN ACTUAL TEMPERATURE AND A/C DOES NOT WORK SUFFICIENTLY	Bulletin No.: 07-003/24
	Last Issued : 05/31/2024

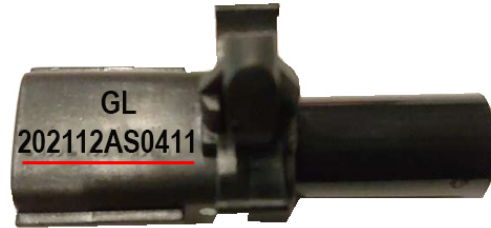
Ambient Temperature Sensor Countermeasure

LOT Number
202112AS0411

- First 4 digits - Year
- Digit 5-6 - Month
- Digit 7-8 - Production Line Identification Code
- Last 4 digits - Product Lot (number assigned to each lot)

Example: 2021 12 AS 0411 = Dec/2021
Lot Number 411

Is the lot number before Lot 0411 of 2021/Dec?

- **Yes** - Replace the ambient temperature sensor according to the instructions in MGSS.
 - Mazda2 (AMBIENT TEMPERATURE SENSOR REMOVAL/INSTALLATION [FULL-AUTO AIR CONDITIONER])
