Subject: WATER PUMP COOLANT LEAK	Service Alert No.: SA-035/24
	Last Issued : 05/31/2024

APPLICABLE MODEL(S)/VINS

2018-2021 CX-3
2020-2025 CX-30
2018-2025 CX-5
2023-2025 CX-50
2025 CX-70
2018-2023 CX-9
2024-2025 CX-90
2018-2025 Mazda3
2018-2021 Mazda6
2018-2025 MX-5

DESCRIPTION

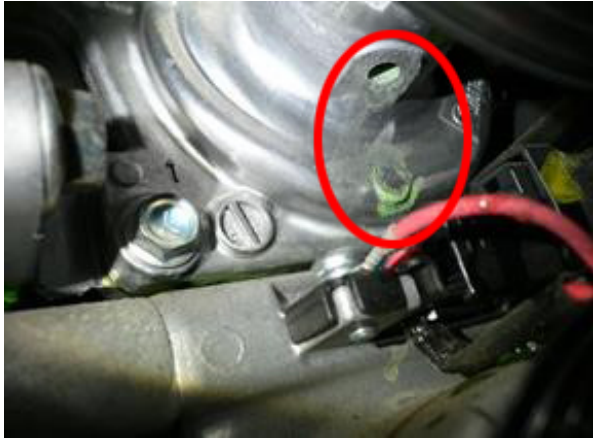
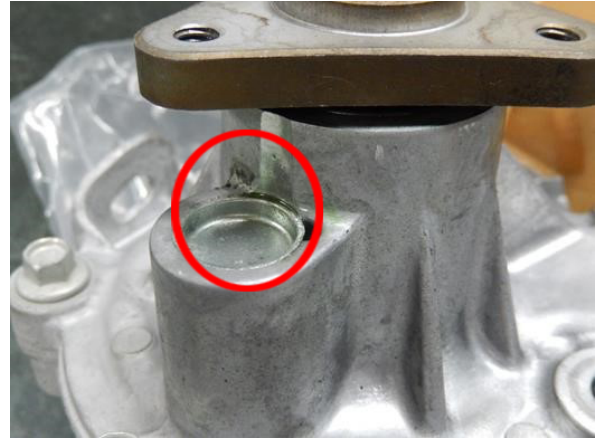
A mechanical seal (A) is used for the water pump. This mechanical seal can seal coolant (B) by sliding a mating ring (C) against a seal ring (D). When the sliding surface temperature of the mechanical seal is more than 248 °F (120 °C) while driving, a small amount of steam (E) is leaked and bleeds through the bleeding hole (F). After drying, the steam leaves a green coolant deposit near the water pump bleed hole (F). This is a normal condition and does not require water pump replacement. The water pump should only be replaced if there is an accumulation of crystallized coolant near the bleed hole.

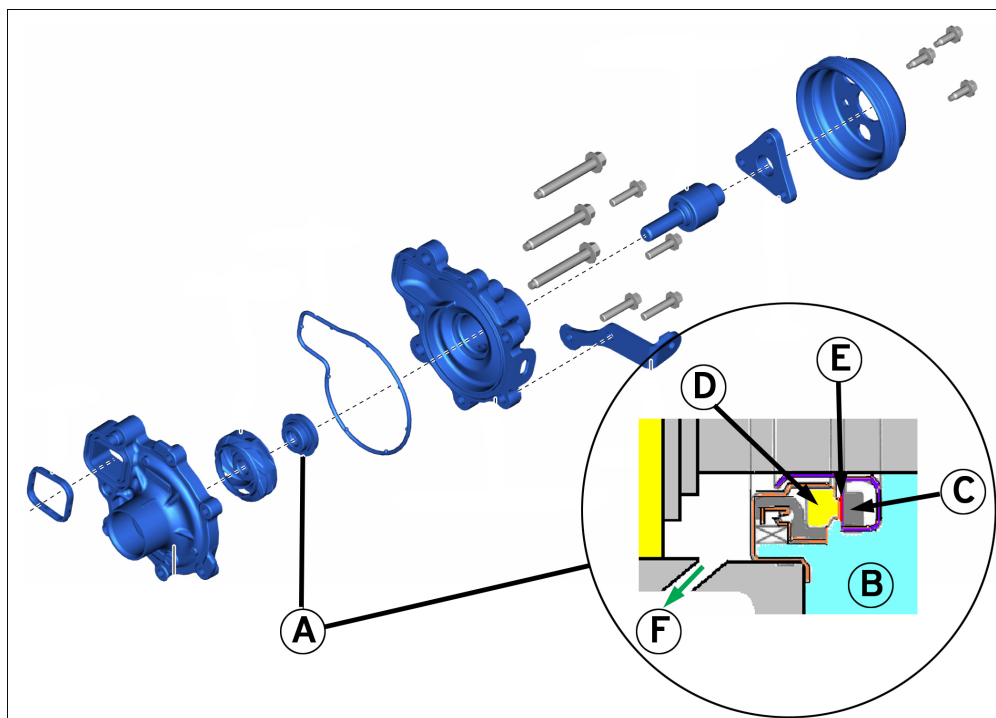
Bleed hole (F) is located under water pump

Dried coolant steam shows as green-color deposit at bleed

hole

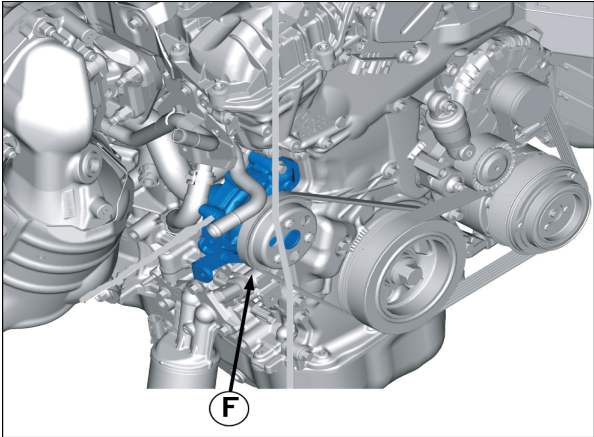
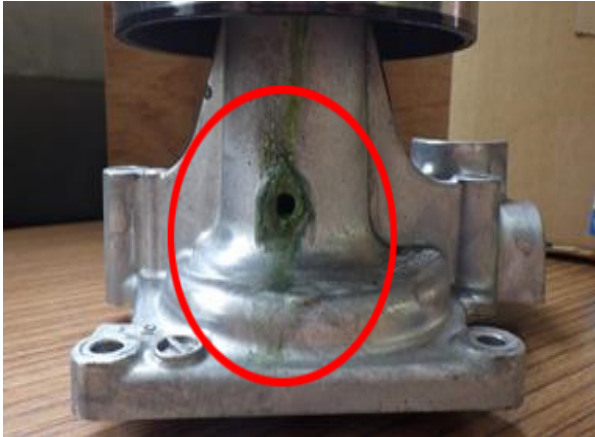
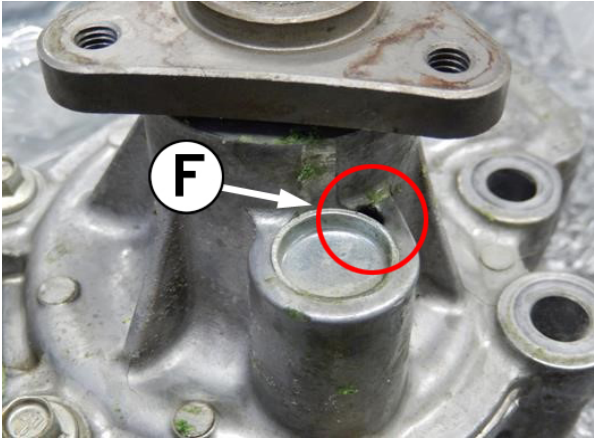
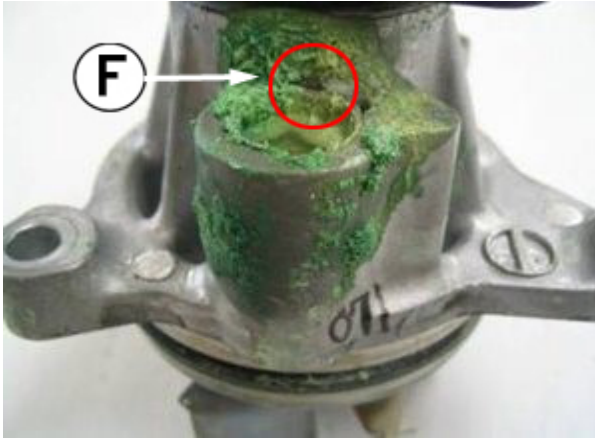
Water Pump Samples:	
<p>GOOD</p> <p>No accumulation of crystallized coolant near the bleed hole (F).</p> <p>DO NOT replace the water pump.</p>	<p>NO GOOD</p> <p>Accumulation of crystallized coolant near the bleed hole (F)</p> <p>REPLACE the water pump.</p>

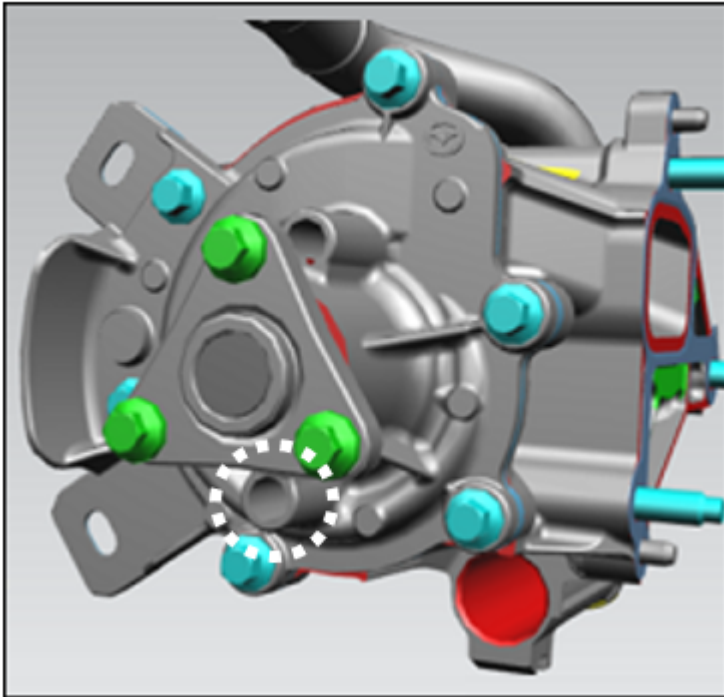
SKYACTIV-G 2.5 (PYUL)

- Regarding the following engines, diagnose whether the water pump requires replacement as with the other engines in this service information.
- Refer to the following images regarding the location of the bleeding hole (white dotted circle).
