Service Alert

Subject: COLOR DISCREPANCIES IN 360° VIEW MONITOR IMAGE	Service Alert No.: SA-036/24
	Last Issued : 05/31/2024

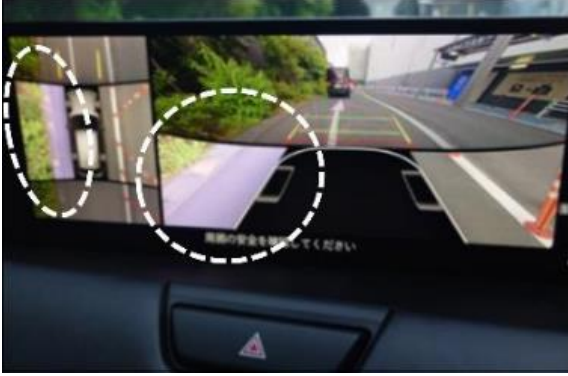
The 360°view monitor is a system that provides a complete picture of the vehicle surroundings by combining the pictures captured by 4 separate cameras. These cameras are installed in the front, rear, right and left sides of the vehicle. Each camera has a color adjustment function (white balance) that operates independently from each other, which can result in color discrepancy when the combined picture is displayed on the screen. This is especially true when one of the cameras captures more green objects than the remaining cameras.

Some customers may complain about color discrepancies (brightness differences) of the image displayed on the screen when using the 360°view monitor. As this phenomenon is not a system failure, **do not make any repairs or replace any parts.**
