Technical Service Bulletin	GROUP CAMPAIGN	NUMBER 24-01-028G
	DATE MAY 2024	MODEL(S) GV70 (JK1A) GV70 ELECTRIFIED (JK1A EV)
SUBJECT: STUCK STEERING WHEEL PHONE CALL BUTTON REPLACEMENT (SERVICE CAMPAIGN T38G)

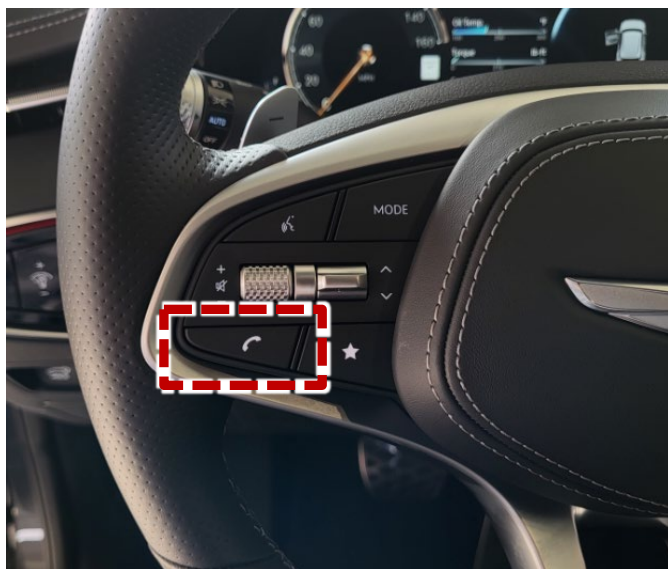
Description: Certain 2023-2024MY GV70 Electrified (JK1A EV) and 2024MY GV70 (JK1A) vehicles may experience a call button getting stuck/no return condition. Follow the information in this bulletin for replacing the phone call button on the steering wheel.

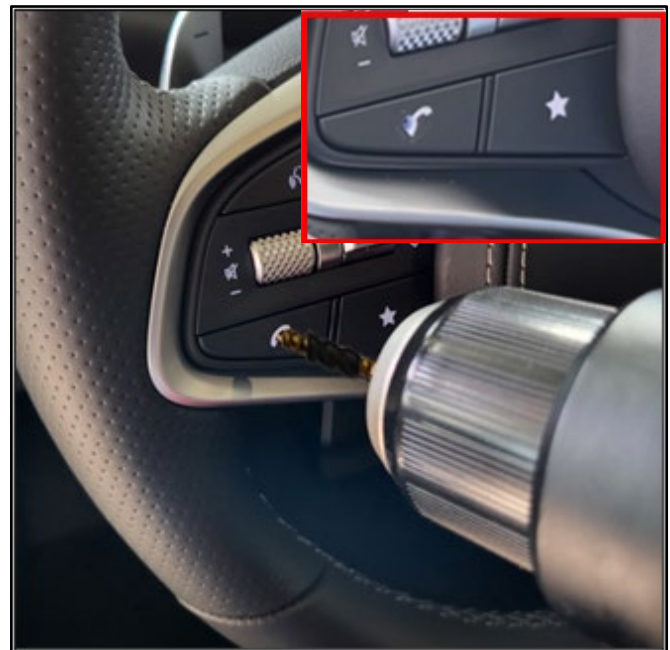
Do not drill deeper than 10 mm (~3/8 in.), as this will damage the bottom surface of the call button.

2. Drill center of remote call button using the drill bit SST.
