# Technical Service Bulletin

GROUP	NUMBER
<b>CAMPAIGN</b>	<b>24-01-005G</b>
DATE	MODEL(S)
<b>JANUARY 2024</b>	<b>GV80 (JX1)</b>

**SUBJECT:** AVN SOFTWARE UPDATE - OVER-THE-AIR (OTA) STUCK  
(SERVICE CAMPAIGN T41G)

**Description:** This bulletin provides instructions to utilize a USB flash drive to update the AVN software for the GV80 (JX1) that experienced an unexpected OTA stop.

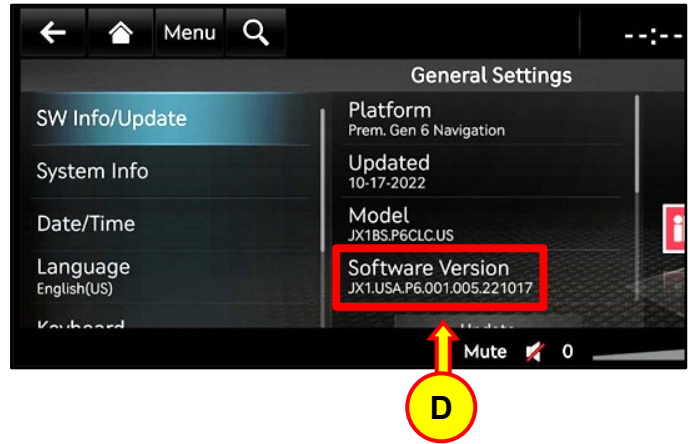
5. Identify the software version (D) and verify the update is required:

- **JX1.USA.P6.001.005.221017** or **JX1.USA.P6.001.005.221025**
  - If the software version does **NOT** match, update is not required.

The updated software version is **JX1\_22.USA.P6.001.007.231101** or later. Any version from **231101** to the latest is acceptable.

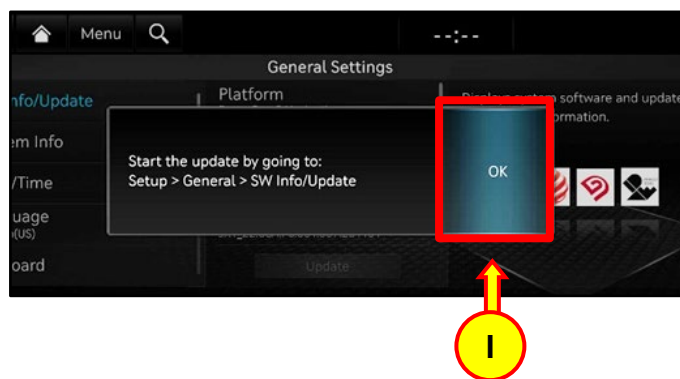
9. If this pop-up window appears, then remove and reinsert the USB flash drive to restart the update.

Select **OK** (I).

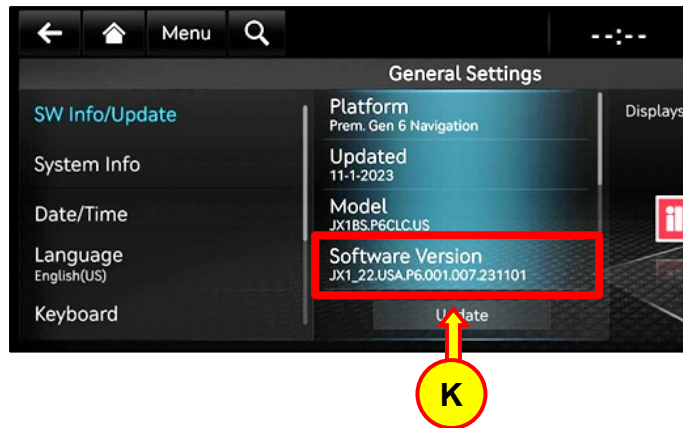
- 11. Verify the latest software version by going to:
  - **Setup > General > SW Info/Update > General Settings**

Ensure that the **Software Version (K)** is **JX1\_22.USA.P6.001.007.231101** or later.
