Technical Bulletin 237  
05.2024

**Item:** 237.1  
**Description:** Suspension Control Unit flagging DTC C1176-86  
**Model Affected:** Tiger 900 GT Pro

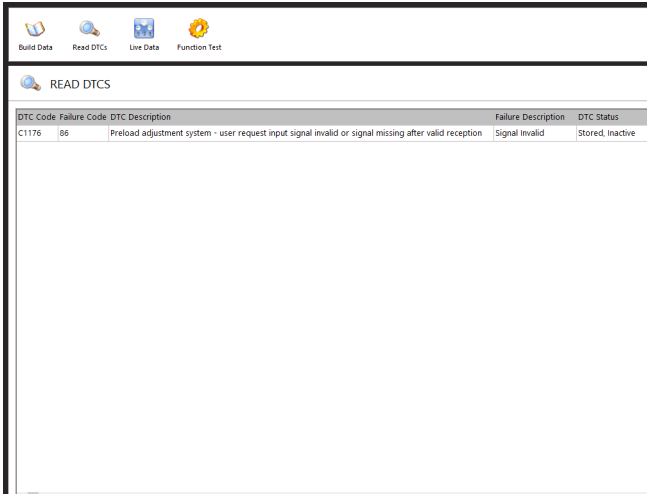
A DTC C1176-86 code is flagged by the Suspension Control Unit (SCU) when the rider switches from Off-road to On-road riding mode (Rain, Road, Sport or Rider). This is due to the delay in the preload setting adjustment being made when switching from the Off-road riding mode. We are working on an update to the instrument software to resolve this issue.

1. Connect the Triumph Diagnostic Tool to the motorcycle as described in the Triumph Diagnostic Tool User Guide and turn the ignition ON.
2. Navigate to **Diagnostics->Suspension ECM->Read DTCs**.
3. If the DTC C1176-86 is detected as shown below, proceed with the following steps:

- If the DTC status is **Stored, Inactive** as shown in the above graphic, click on **Erase DTCs** and conclude the test.
- If the DTC status is **Stored, Active**, investigate and rectify the issue by following the pinpoint test as described in the service manual.
