SERVICE BULLETIN

APPLICABILITY: 2022 MY BRZ

NUMBER: 12-246-24

SUBJECT: Lower Center Panel – Design Change

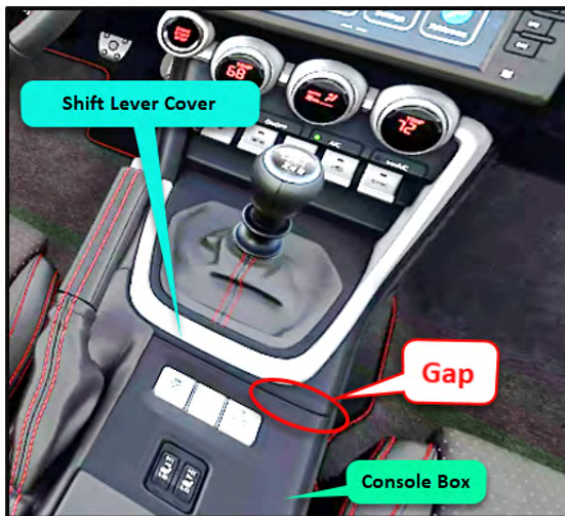
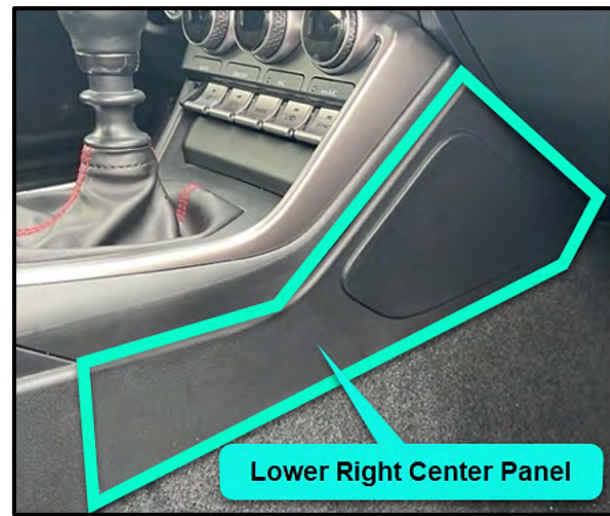
This bulletin announces the design change made to the lower right center panel. The change was incorporated to address cases of excessive passenger side gap between the shift lever cover and the console box. The new console panel has been reshaped to provide added rigidity and allow the shift cover to sit more evenly. If this gap is reported, replace the lower right center panel with the new part.

Part Description	Part Number
PANEL-CENTER LOWER, RIGHT	66241CC031
