## SERVICE BULLETIN

**APPLICABILITY:** 2023-24MY Ascent  
2023-24MY Legacy & Outback

**NUMBER:** 07-225-24R

**SUBJECT:** EyeSight Reprogramming Files / DTCs B28C7, B28A6, Halt Code E5

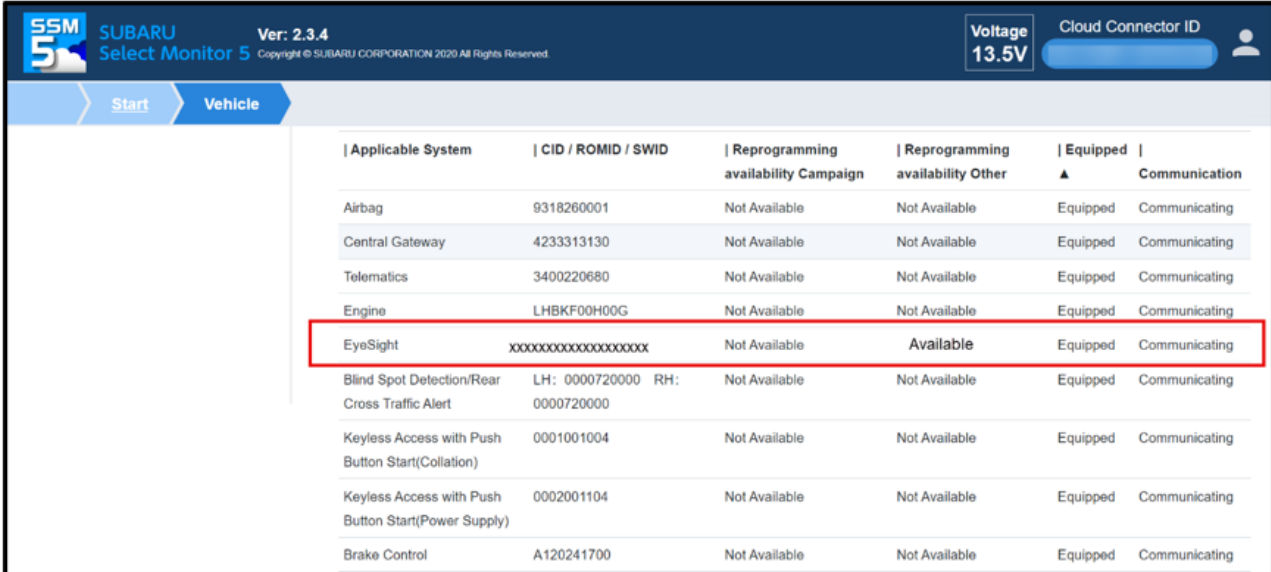
**STEP 5:** Using the Subaru Select Monitor 5-R (SSM5-R), confirm the following EyeSight Stereo Camera Assembly information:

The reprogramming column reads “**Available.**”

**STEP 7:** Reprogram the EyeSight Stereo Camera Assembly following the normal SSM5-R procedure and confirm the CID/ROMID/SWID has changed to the following:

- **Legacy Outback ONLY:** The NEW CID/ROMID is **1A210800430E21080138**.
- **Ascent ONLY:** The NEW CID/ROMID is **0521081E4C0E21080138**.
