ZF/TRW Steering Gear Side Cover Leak

Published 24 May 2024

Mack - All model equipped with steering gear PN 23490318

Volvo - All model equipped with steering gear PN 23490318

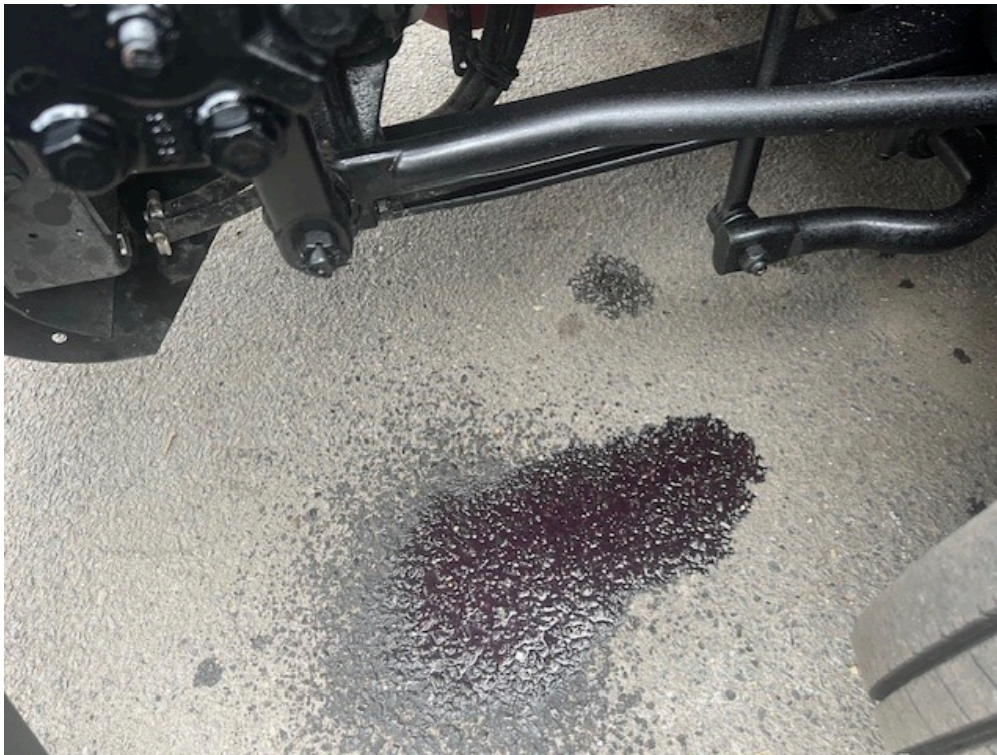
1. Inspect for Fluid: Place a drain pan under the steering gear to catch any leaking fluid.
