## STAR ONLINE PUBLICATION

**Case Number:** S2208000063 Rev. A

**Symptom/Vehicle Issue:** Loss Of Power Steering Assist. U0131 Lost Communication With Electro Hydraulic Power Steering Control Module (EHPS).

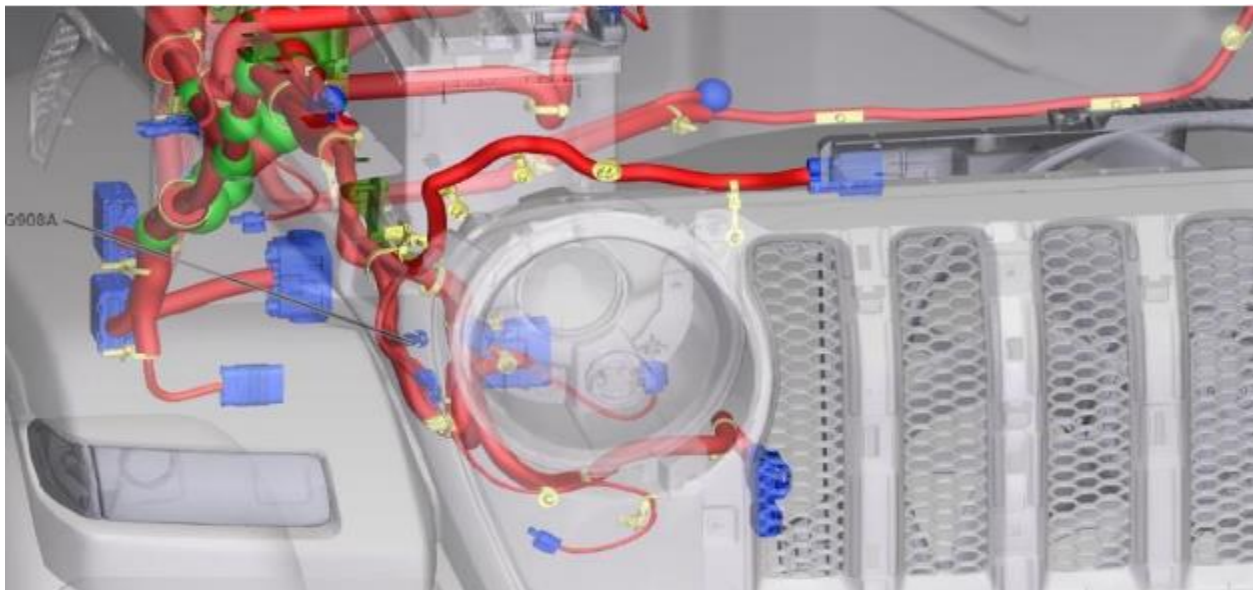
Fig 1. G908A location.

**Discussion:** The customer may experience a lack of power steering assist. Diagnostic trouble code (DTC) U0131 - Lost Communication With Electric Power Steering Control Module may be present. This may be caused by the ground wire not being fully welded/secured to the ground eyelet.

**Diagnosis:** Inspect the G908A ground located behind the passenger side headlight. Determine if the ground eyelet is properly secured to the ground wire. Check if the eyelet from the power steering ground is bent. If it is, carefully bend it back straight (Fig. 2).

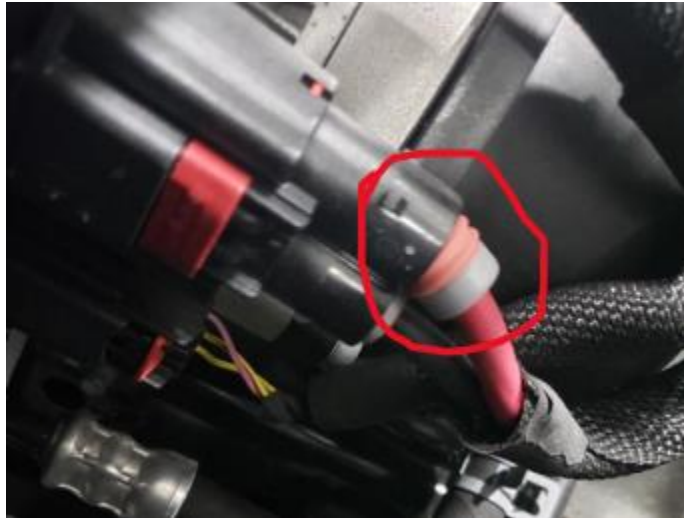
Example Of Pin Push Out.

Using a multimeter verify power and ground at the EHPS C1 connector. C2 connector has pins for CAN communication and Ignition Run Start. Inspect each for problems including pin pushout and harness routing. Repair as needed.
