STAR ONLINE PUBLICATION

Case Number: S2408000045

Symptom/Vehicle Issue: Check Engine Lamp (CEL) is on, Cluster Message to Service the Shifter

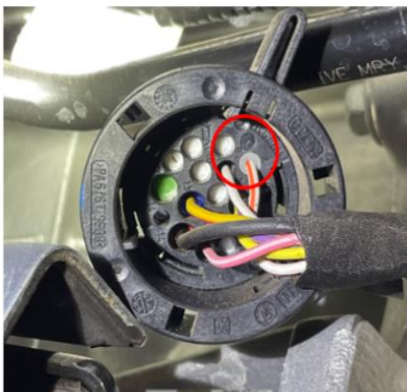
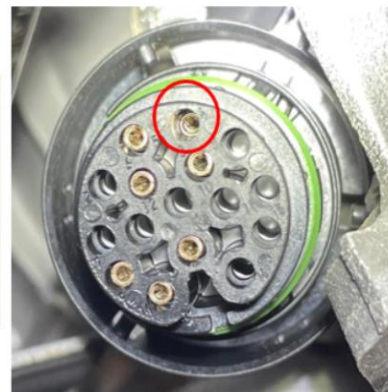
Transmission connector D2735A - Terminal Pull Out

Repair Procedure: Locate and unplug chassis harness TCM connector D2735A. Inspect the terminals for a pushed-out condition (see reference image attached). If inspection reveals a terminal pushed-out (TPO) or a spread terminal, repair the connector as needed, repair kit 68305267AA.
