Technical Service Bulletin

GROUP CAMPAIGN	NUMBER 24-01-038H
DATE MAY 2024	MODEL(S) KONA (SX2)

SUBJECT: FRONT PASSENGER SEAT RATTLE NOISE REPAIR
(SERVICE CAMPAIGN TBI)

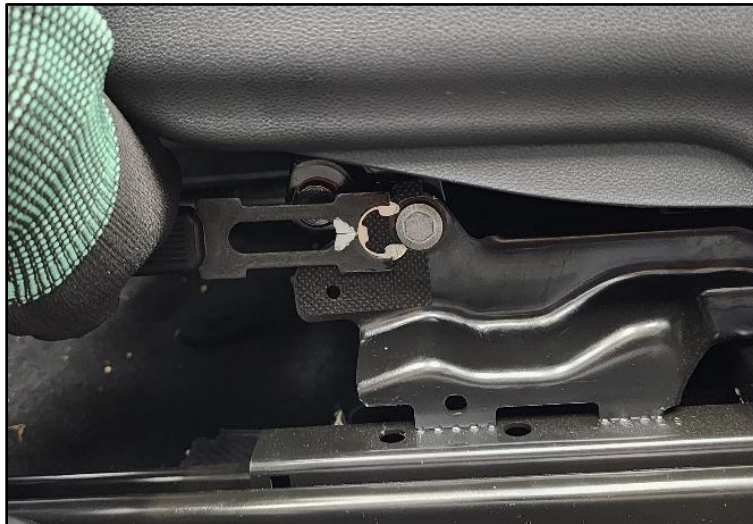
Description: Certain 2024MY Kona (SX2) vehicles may exhibit a rattle noise from the front passenger non-power (manual) seat while driving, caused by excessive tolerance within the seat track assembly. Follow the procedure in this bulletin to inspect the gap between the self-clinching stud and seat track and install the correct E-clip that corresponds to the gap size.

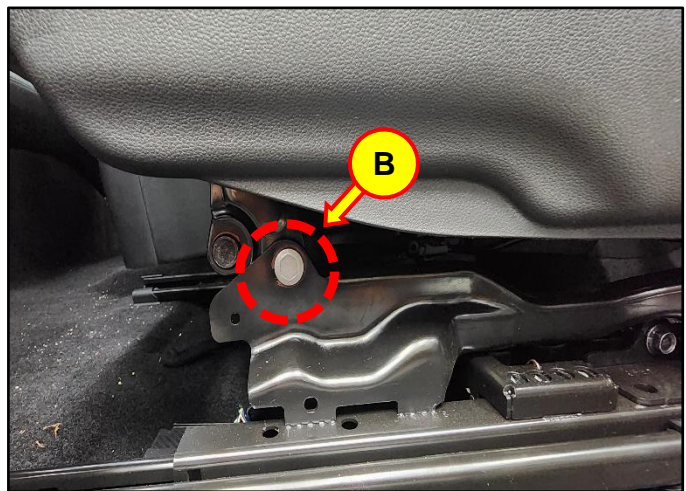
2. Locate the self-clinching stud (B) at the bottom of the front passenger seat track.

3. Measure the gap between the self-clinching stud (B) and the existing E-clip using the supplied thickness gauge set (C).

If the gap is measured to be **0.1 T** or less, proceed to step 12 and do not install any E-clips.

If the gap is measured to be **0.2 T** or more, proceed to the next step to install the corresponding E-clip.
