## Technical Service Bulletin

GROUP <b>CAMPAIGN</b>	NUMBER <b>24-01-033H</b>
DATE <b>MAY 2024</b>	MODEL(S) <b>KONA (OS) KONA ELECTRIC (OS EV)</b>

**SUBJECT:** OUTER TAILGATE HANDLE SWITCH REPLACEMENT  
(SERVICE CAMPAIGN TBQ)

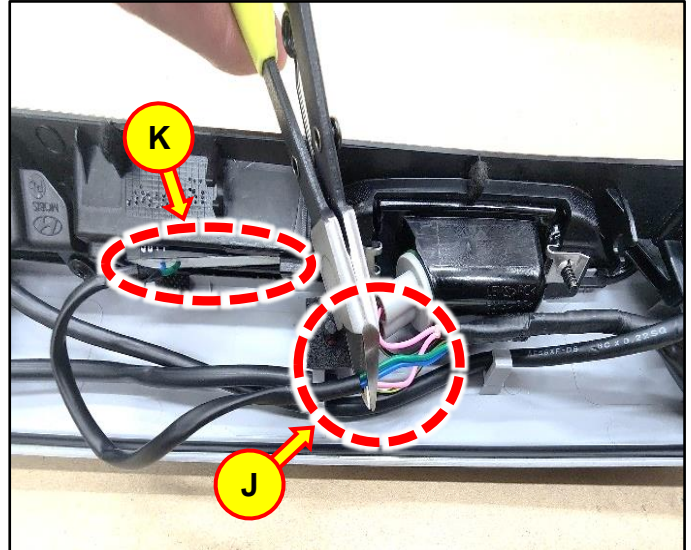
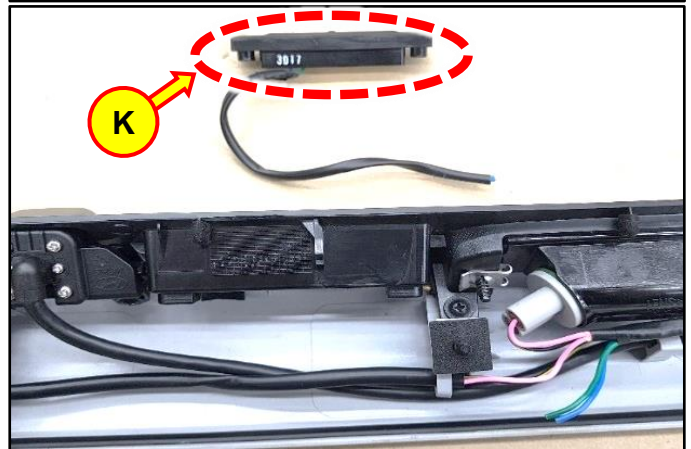
**Description:** This bulletin provides information to replace the outer tailgate handle switch due to a defective rubber injection which allows water to leak into the switch, potentially hindering proper tailgate opening.

10. Cut the ends (J) of the wires connected to the outer tailgate handle switch and remove the switch (K).
