STAR ONLINE PUBLICATION

Case Number: S2308000151 Rev. A

Symptom/Vehicle Issue: Key Fob Battery Low Warning Message Displayed on The Instrument Panel Cluster (IPC)

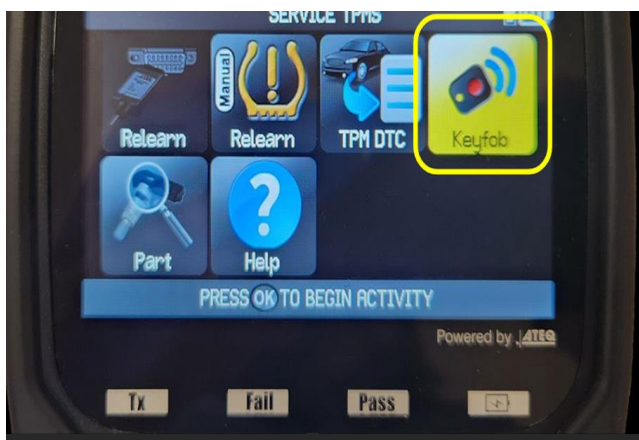
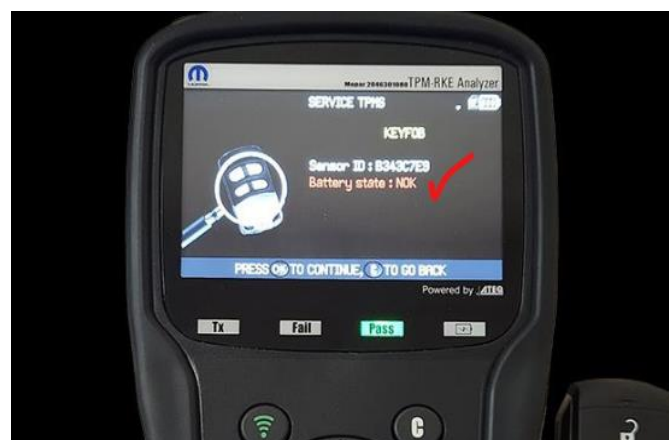
If the concern is present and the FOB battery is ok, inspect for aftermarket equipment (cell phone chargers, cell phones, LED lamps and any other aftermarket installed equipment that can be creating signal interference. If intermittent confirm all system antennas are secure with no damage.
