## STAR ONLINE PUBLICATION

**Case Number:** S2423000019 Rev. A.

**Symptom/Vehicle Issue:** Water Leaking Into Interior At D-Pillar Or Liftgate.

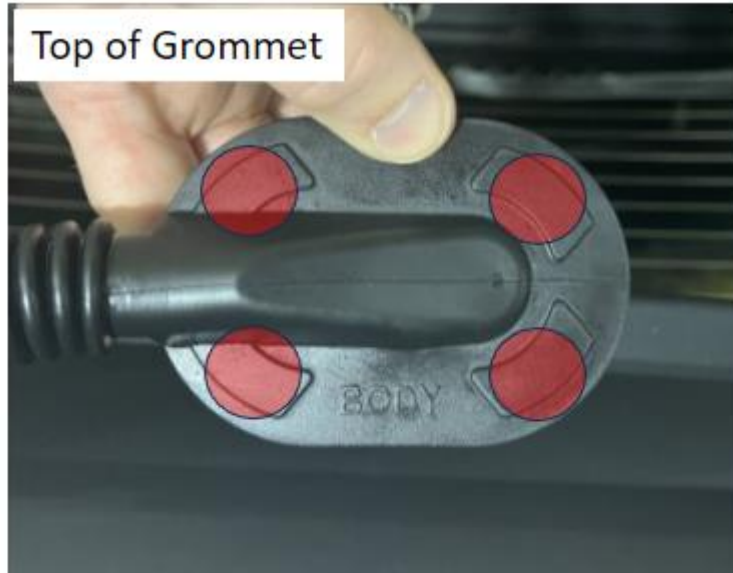
Top of Grommet

1. Liftgate wiring grommet. Inspect the wiring pass through grommet for the liftgate. A grommet that is not fully seated can cause a water leak into the interior or into the liftgate. The base of the grommet clips and seats on both the liftgate and body side. Use finger pressure at each of the red indicated areas to firmly snap the grommet into place. See the below figure for a visual aid.

To inspect for proper seating of the grommet push down on the four (4) highlighted areas

It works best pushing down using both hands at the same time

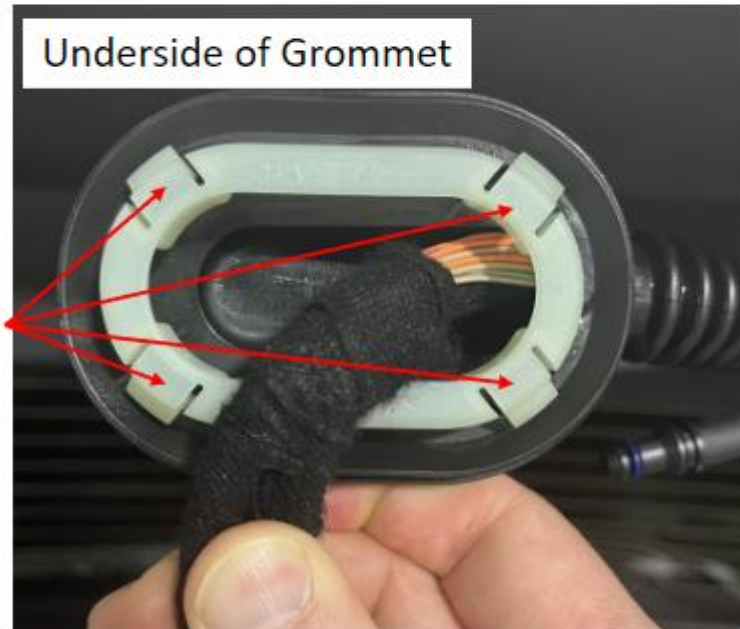
Underside of Grommet

If any of the clips are not seated, you will hear/feel a click
