**Panamera E-Hybrid - “Please unplug charger” Message in Instrument Cluster**

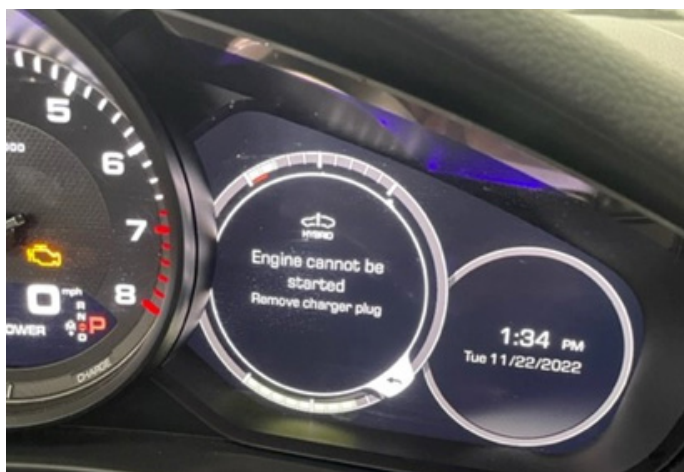
Figure 1

Following a software update or installation of a replacement 3.6 kW On-Board Charger (OBC), the workshop finds a white hybrid warning in instrument cluster as shown below. This message occurs on start-up even when no HV charging plug is connected. Fault B19DAF0\_EA6639 is present in the Instrument Cluster control unit.

This condition is due to a known software error in newly produced replacement 3.6 kW Onboard charger (OBC) parts with software level 6021. The issue is currently under investigation between PAG and the supplier.

There is currently no fix available for this condition with the existing stock of OBC parts (PN PAB915682B). If a vehicle arrives and diagnosis leads to need of an exchange OBC, then it is recommended to delay OBC replacement until updated parts with corrected software are available.
