Grinding Marks on the Wheel Housing Liner after Racetrack Use: Replacing Wheel Housing Liners (SY 69/24)

Vehicle Type: **911 GT3 RS (992)**

Model Year: **As of 2023 up to 2024**

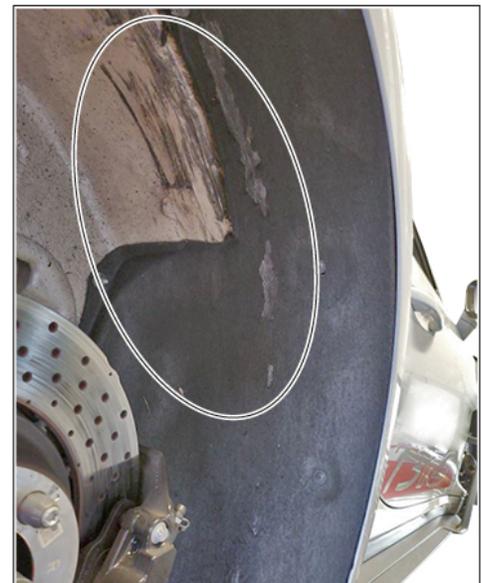
Symptom: **Grinding marks on the front and/or rear wheel housing liners.**

Cause: During racetrack use, excessive accumulation of tyre abrasion (“pick-up”) can lead to thickening of the tyre and thus briefly to a contact between the wheel and wheel housing liner in extreme driving situations. This can cause grinding marks on the wheel housing liners during the service life. ⇒ *Grinding marks on wheel housing liner*

Grinding marks on wheel housing liner

Action: On vehicles that were manufactured **before the use of optimized wheel housing liners** and that have the described fault pattern, replace the wheel housing liners (each consisting of a front section and a rear section) in all four wheel housings at one time with parts featuring an optimized design.

- Work Procedure: 1 Check wheel housing liners and confirm the fault pattern.
- 2 Replace all wheel housing liners once with wheel housing liners with the optimized component status.
- ⇒ *Workshop Manual '50561901 Removing and installing front wheel housing liner (front section)'*
 - ⇒ *Workshop Manual '50561903 Removing and installing wheel housing liner front (rear section)'*
 - ⇒ *Workshop Manual '536919 Removing and installing rear wheel housing liner (front section)'*
 - ⇒ *Workshop Manual '53691903 Removing and installing rear wheel housing liner (rear section)'*
