Troubleshooting: Front Window Pane Reversed – Closes and/or Opens Incorrectly (55/24)

Model Line: **Cayenne (9YA / 9YB)**

Model Year: **As of 2019**

Concerns: **Front window pane**

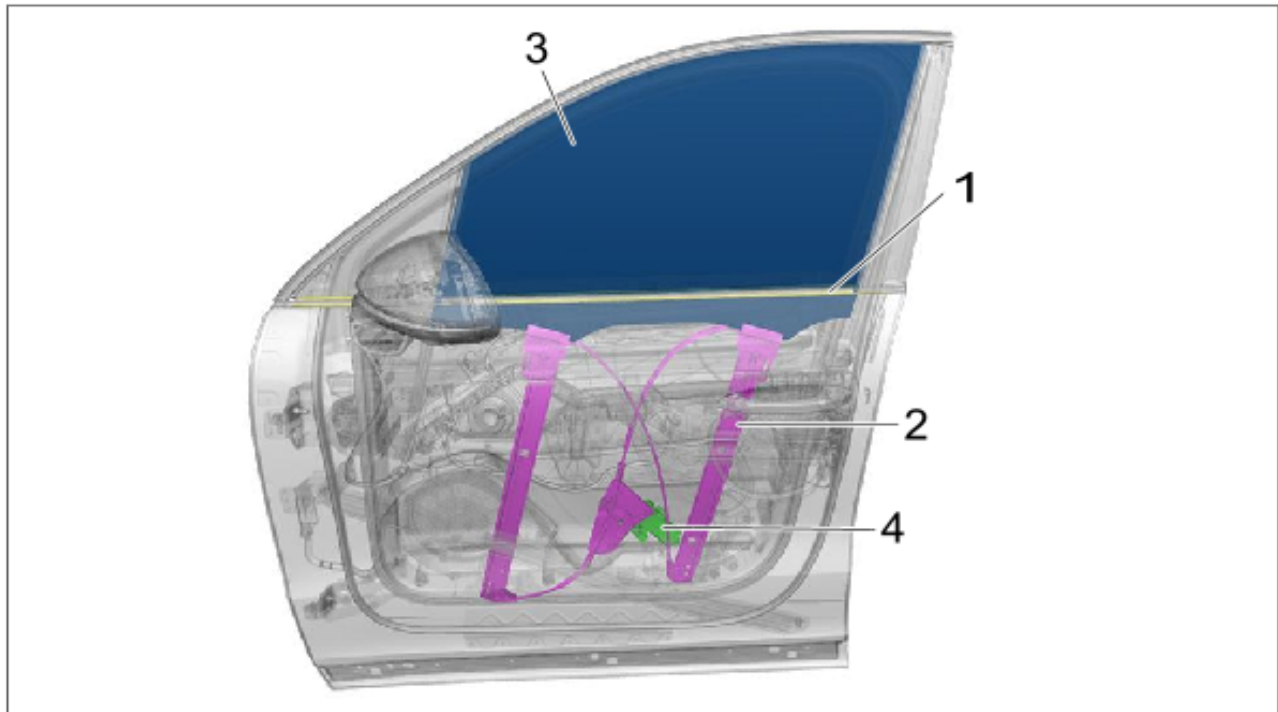
Overview of causes for front power windows malfunctions

- Deformed/damaged window shaft seal ⇒ *Overview of causes for front power windows malfunctions -1-* in the window guide
- Resistance inside the front power windows mechanism ⇒ *Overview of causes for front power windows malfunctions -2-* due to contamination or lack of lubrication
- Dirty window pane ⇒ *Overview of causes for front power windows malfunctions -3-* / high friction on the window pane ⇒ *Overview of causes for front power windows malfunctions -3-*
- Faulty power windows motor ⇒ *Overview of causes for front power windows malfunctions -4-*

- 1 – Window shaft seal
- 2 – Front power windows mechanism
- 3 – Front window pane
- 4 – Power windows motor

(x)	The window shaft seal is dirty.	Clean the window shaft seal. Then continue with Step ⇒ 10.
(x)	The window shaft seal is damaged.	Replace the window shaft seal. ⇒ <i>Workshop Manual '644819 Removing and installing front window shaft seal'</i> Then continue with Step ⇒ 10.

(x)	Window pane has dirt or deposits that increase friction.	Clean the window pane and remove friction-increasing deposits. Then continue with Step ⇒ 10.

(x)	The front power windows mechanism has blockages or contamination or is not sufficiently lubricated.	Clean, repair and lubricate the front power windows mechanism. If irreparable, replace the front power windows mechanism. ⇒ <i>Workshop Manual '645219 Removing and installing front power windows'</i> Then continue with Step ⇒ 10.
