Display of “Coolant temperature too high” in Group V6 and V8 Engines

Vehicles Affected

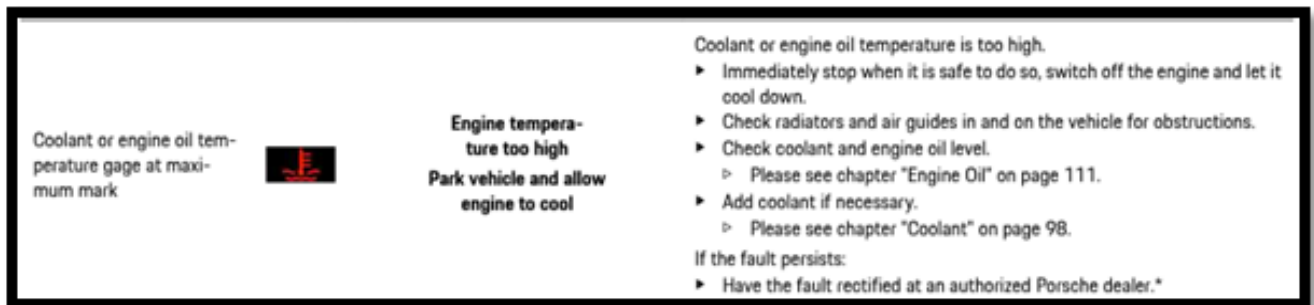
Customer complains about “Coolant temperature too high” warning message, Instrument Cluster fault code B19A7F0.

Figure 1 - Owner's Manual Information for Over-Temperature Warning (B19A7F0)

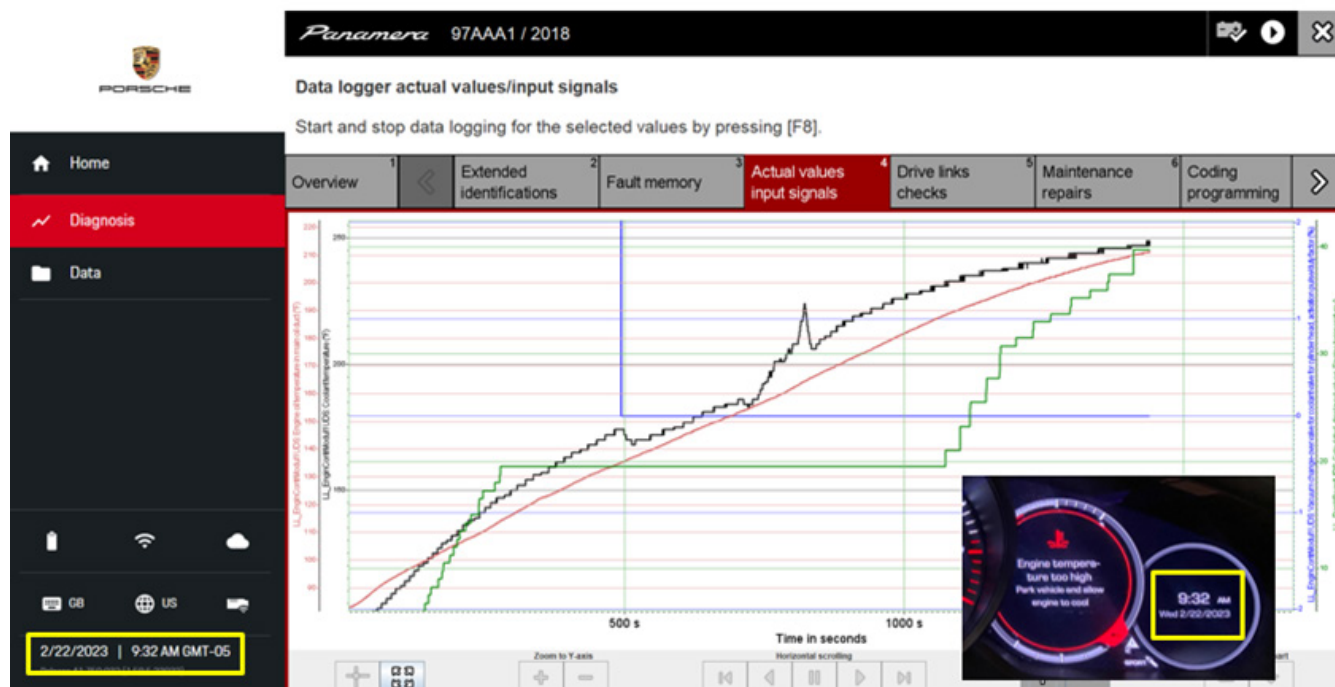
The aforementioned warning message in the instrument cluster (IC) only displays when the coolant temperature exceeds the warning threshold. The vacuum changeover valve controlling the water pump's sleeve in the aforementioned engines is known to intermittently stick, thus causing the overheat warning in the IC.

Figure 2 simulates an overheat condition by overriding the changeover valve for the coolant pump sleeve. For this simulation, the valve's electrical connection to the DME remained intact, but the simulation removed the valve from the vacuum lines, forcing the coolant pump's sliding sleeve to remain in the blocked flow position (no coolant circulation). Thus, the simulation's data of Figure 2 shows a 'forced' overheat condition from cold-start. In this simulation, the DME commands the changeover valve to switch, opening the pump's sleeve, allowing coolant to circulate (if the valve was connected). The blue series line shows this switch around 500 seconds of engine run time. Because the valve is not in-line with pump's vacuum supply (removed except electrically), the sleeve never opens, and the IC warning "Display of coolant temperature too high, active" results after approximately 25 minutes.

Figure 2 - Tester Tracing of Forced Overheating from Overridden Water Pump Changeover Valve

Please follow the function test as outlined in "TI, 1950 Warning Message "Coolant Temperature Too High": Checking Coolant Pump and Change-Over Valve (173/21)" The vacuum changeover valve controlling the water pump's sleeve in the aforementioned engines is known to intermittently stick, thus causing the overheat warning in the IC. Therefore, it is imperative to check its function as thoroughly as possible under various temperature conditions, because temperature can play a role in its behavior.
