Technical Service Bulletin

GROUP CAMPAIGN	NUMBER 24-01-019H
DATE MAY 2024	MODEL(S) IONIQ 5 (NE1)

SUBJECT: TMK SEALANT LEAKAGE INSPECTION/PARTS REPLACEMENT
(SERVICE CAMPAIGN TBM)

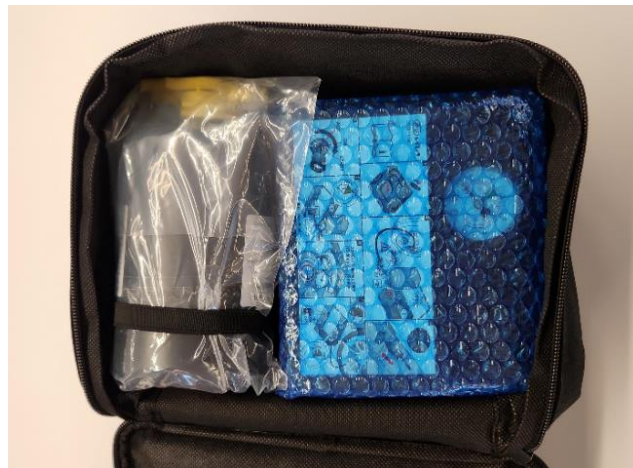
Description: Some 2023-2024MY IONIQ 5 (NE1) vehicles may have sealant leakage in the Tire Mobility Kit (TMK). The leakage may contaminate other parts inside or outside of the TMK bag. Follow the procedure in this bulletin to determine if the sealant is leaking and, if necessary, replace any parts that have been contaminated. If the sealant has not leaked, replace only the TMK Sealant Cap.

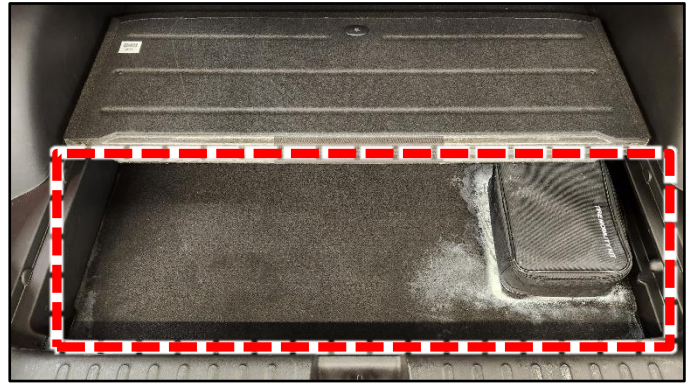
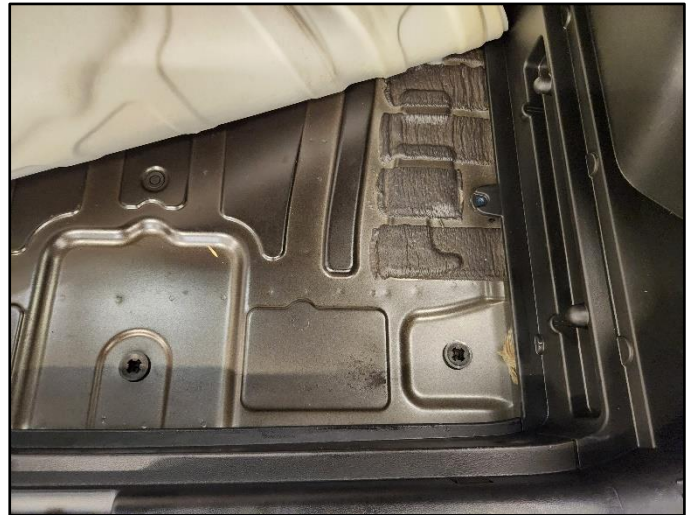
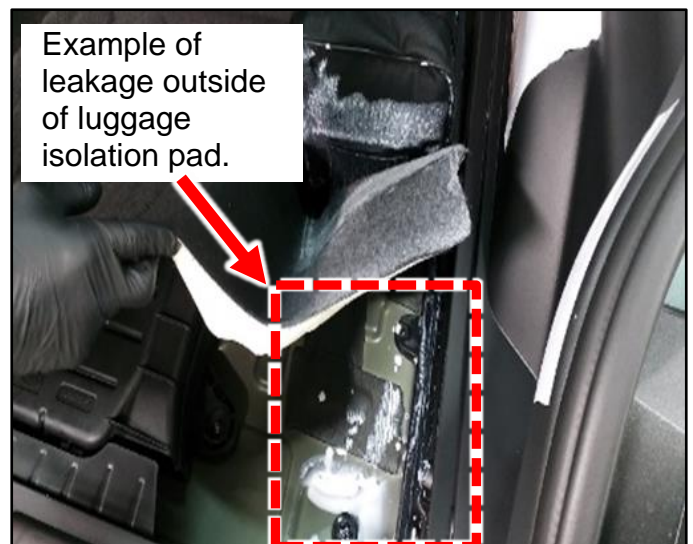
1. Open the trunk and check for TMK sealant leakage near the TMK bag and surrounding area.
2. If the luggage isolation pad is contaminated, remove and discard it.

3. Inspect the area under the luggage isolation pad for contamination and clean as necessary.

- If sealant has hardened, it has rubber-like properties (like an eraser), and may come off easily by rubbing with a dry towel.
- If the cured sealant does not come off, rub it with a wet towel for about 1-2 seconds and then rub off with a dry towel.

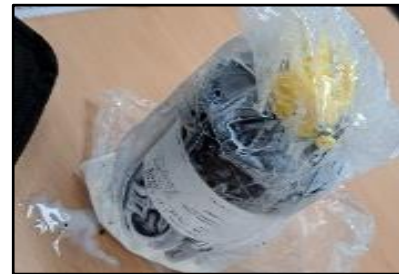
Example of Sealant Container Leakage

5. If there is sealant leakage inside the TMK bag (see example), discard the entire TMK & Tool Set.

6. Install the new TMK & Tool Set.
