CAL FTL 08-001

Subject: New Cascadia Vehicles Produced at Cleveland, Equipped with Cummins Engines-Inspection for Properly Torqued Engine Mount Bolts

Make: Freightliner

Model: New Cascadia

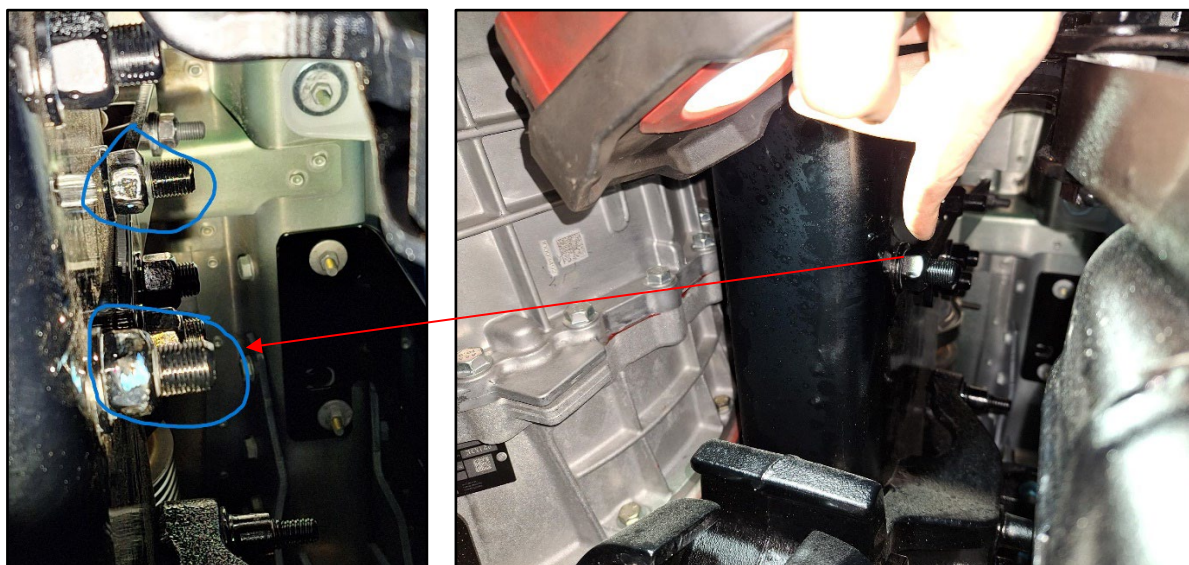
After finding one vehicle with insufficiently tightened bolts on one of the engine mounts, DTNA has taken a proactive approach to assess if other vehicles may have the same issue. With the following inspection, the vehicles will be surveyed to collect more evidence.

Fig. 1, Loose or Missing Rear Engine Mounting Bolts

5. Remove the splash shield by pulling it forward until it clears the rocker panel, then pull it to the side.
6. Inspect the rear engine mount bolts for loose bolts. See **Fig. 1**.
7. Using a 15/16" wrench and a 15/16" socket, torque all four engine mount bolts on each/both left and right rear engine mount to 173 lbf·ft (235 N·m). See **Fig. 2** for correct bolts.
8. Position the splash shield so that the cab studs align with the splash shield holes. Install the two backing plates and the four nuts on the studs. Tighten the nuts 15 lbf·ft (21 N·m).
9. Install the screw that attaches the splash shield to the front-wall mounted bracket.

3. Inspect the rear engine mount bolts for loose bolts. See **Fig. 1**.
4. From underneath, use a 15/16" wrench and a 15/16" socket, torque all four engine mount bolts on each rear engine mount to 173 lbf·ft (235 N·m). See **Fig. 2** for correct bolts.
5. Close the hood.

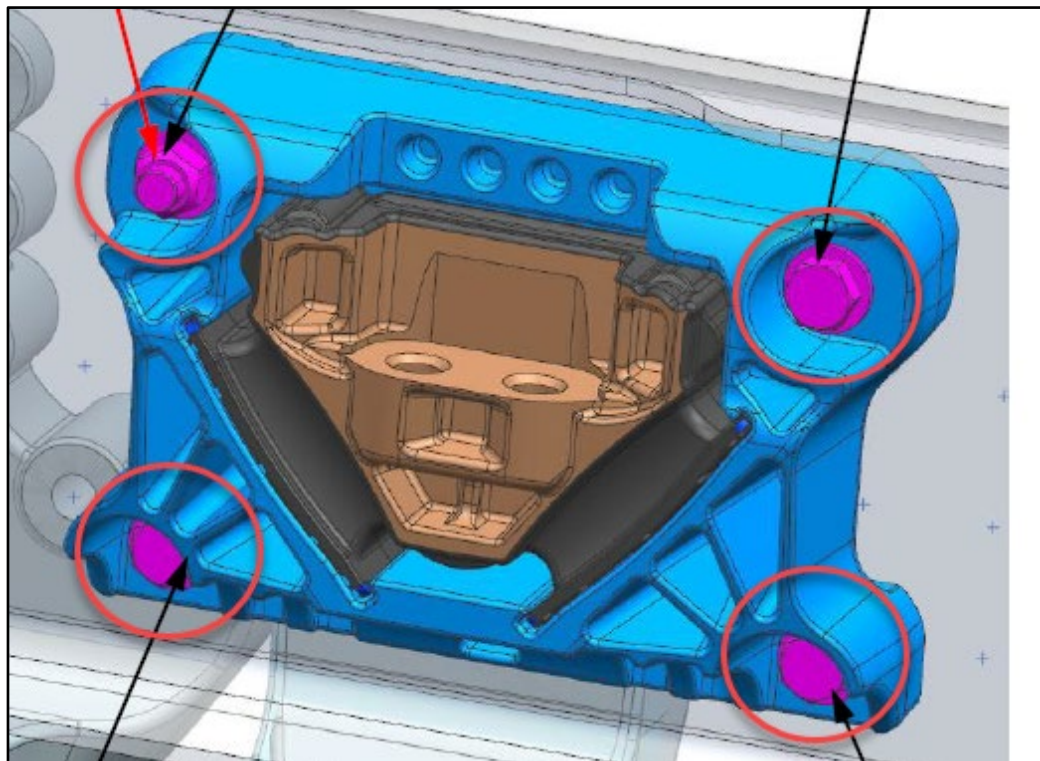
Fig. 2, Four Bolts with Torque Tool Installed.
