05/01/2024  
CAL FTL 54-027

## Subject: New Cascadia Vehicles Equipped With D-Climate P4 Ground Cable Anti-Corrosion Sealer Issue

**Model:** New Cascadia

**Model Year Affected:** 2020 to 2022

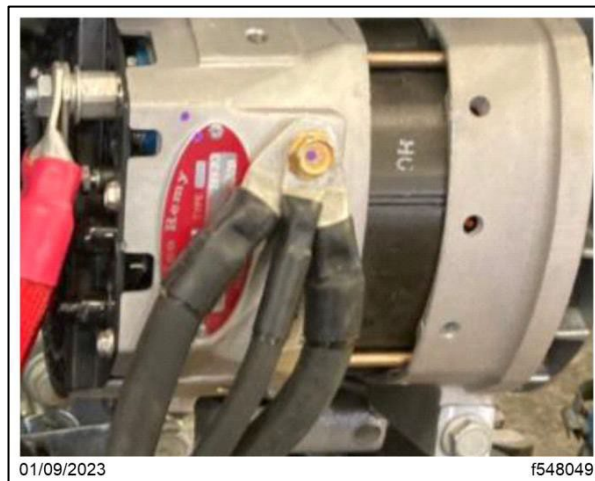
Some New Cascadia vehicles equipped with the D-Climate system have the ground cables installed on the alternator body in a manner as shown in [Fig. 1](#) that, once the spray is applied, it can interfere with the optimal grounding. See [Fig. 2](#). A further improved configuration will be described below and shown in [Fig. 3](#).

**Fig. 1, Ground Cables Mounted on the Alternator**

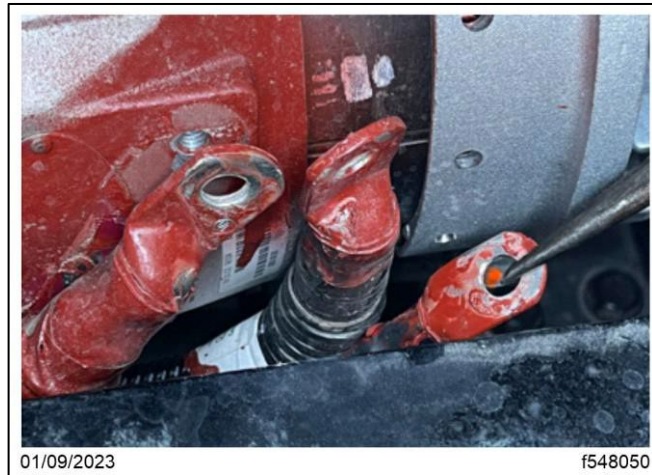
**Fig. 2, Corrosion Sealer Applied on the Ground Cable Mounting Eyes**

1. Park the vehicle on a level surface, shut down the engine, and apply the parking brakes. Chock the tires.
2. Disconnect the batteries.
3. Remove the ground cable mounting screw on the alternator case. Remove the red dielectric paint from the mating surfaces with an acceptable cleaner as shown in **Fig. 2**.

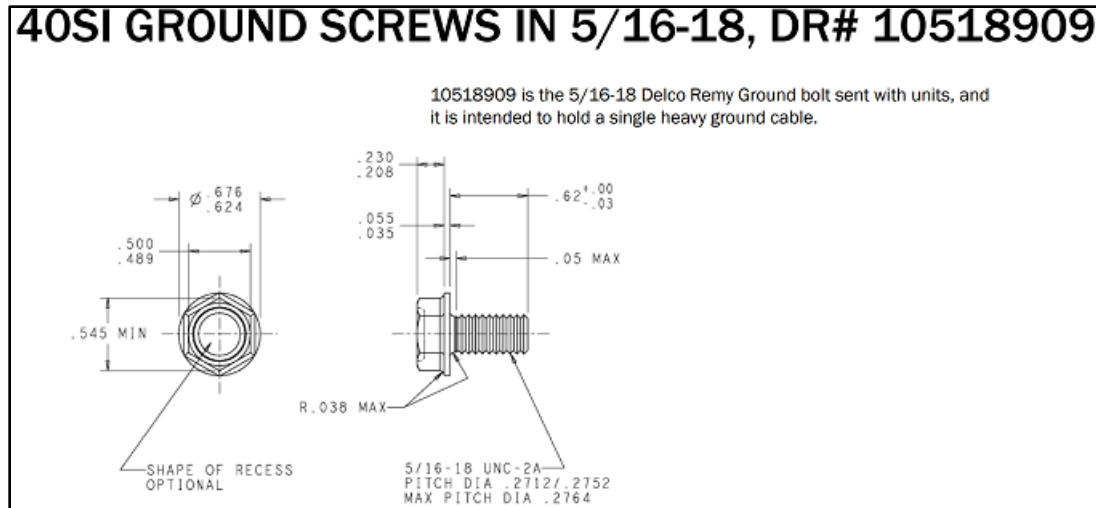
**Fig. 6, Delco Remy Approved Fastener DR 10518909**

**Note:** If an excessively long fastener is installed in any of the three grounding locations, damage to the stator may result as Delco Remy 40SI alternator grounding locations are 'through holes' rather than 'blind holes.'

7. Install the ground cables in both locations with the correct Delco Remy approved fastener as shown in [Fig. 6](#). As a reference, 0.625 equals to 5/8". The 0.62 dimension of DR 10518909 is intended for the original OEM signal ground cable only, and may have been discarded in favor of a longer fastener when three cables were stacked onto the center OEM alternator ground location. If a non-DR approved dimension fastener is present, discard it.

8. Tighten the capscrews (DR 10518909) in both the grounding locations 60 to 90 lbf·in (678 to 1017 N·cm).
