31-032 SRRR Bracket Assembly Replacement

PB-31-032-FTL

►eCascadia

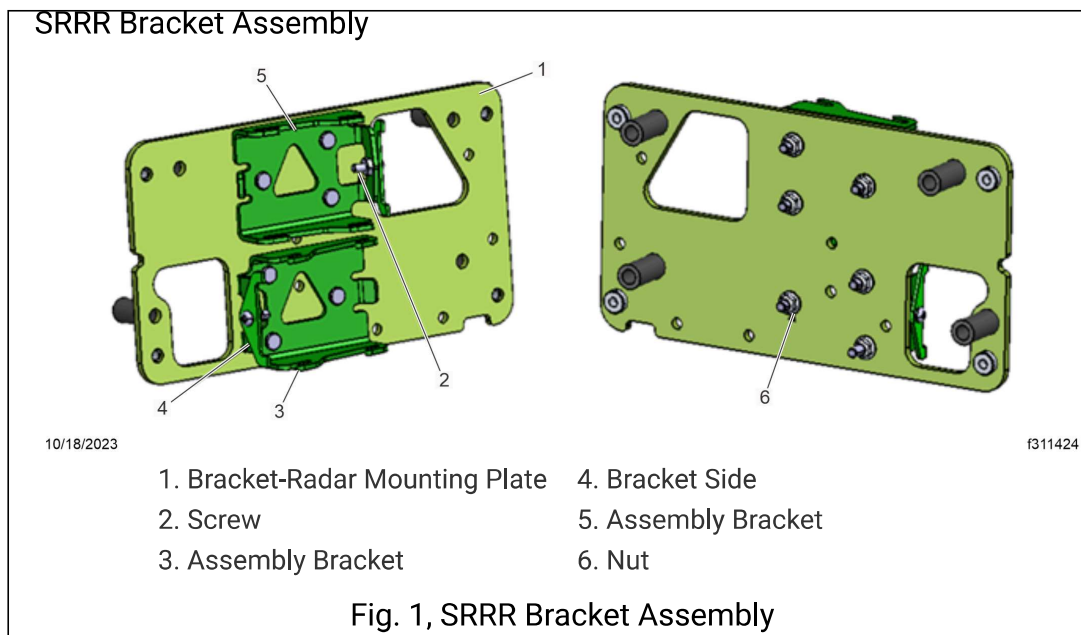
Short range radar right (SRRR) bracket assembly (A66-28620-000) is no longer available and has been replaced by a new design that may require replacement with a collection of parts found in BOM 73S-C00102. See figure [1](#).
