35–039 Detroit New Final Drive Standard Performance Forward Carrier Change to Top Performance Passive Lube Management

TSB-35-039-FTL

Last Revision Date:2024-05-14

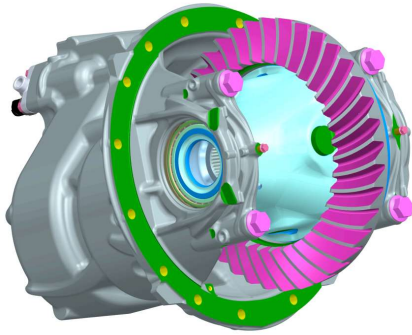
Fig. 1, Original Standard Performance Carrier without a Lube Management System

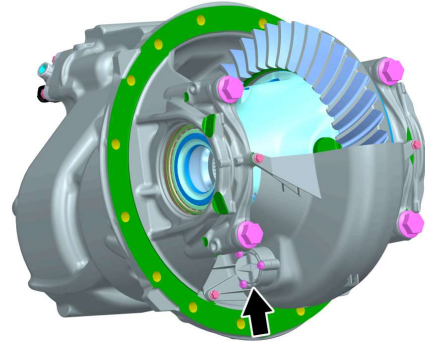
Detroit New Final Drive Standard Performance Axles will have a change to the lube management system. Initially launched without a lubrication management system, the forward rear axle will change to a passive management system. This will be the same passive lube management system as the New Final Drive Top Performance Axle with passive lube management.

Fig. 2, New Standard Performance Forward Passive Lube Management Carrier with Fixed Valve

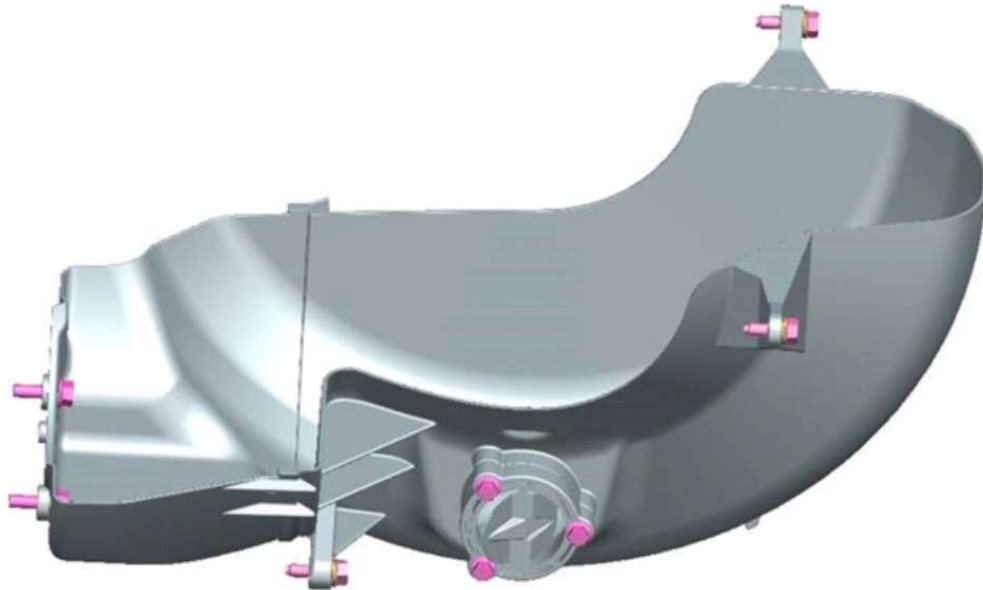
Fig. 3, New Passive Lube Management Valve and Windage Tray

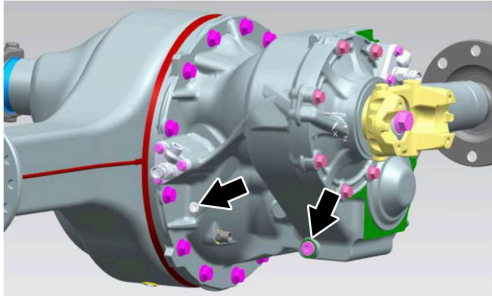
Oil fill locations will change to match the New Final Drive Top Performance locations. See Fig. [4](#). The type of approved oil is DFS93K219.01 only. The rear fill plug part number on the axle housing will change to a new part number (MBA 6809900117), and it will be installed from the inside, similar to the Top Performance carrier. See Fig. [5](#).

Fig. 4, New Fill Locations for New Final Drive with Passive Lube Management System

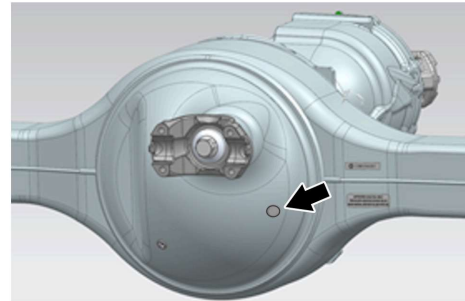
Fig. 5, Old Fill Plug Blocked with New Plug Inserted from Inside of the Carrier Housing

1. In order to replace the carrier, clean the housing, and remove the external fill plug from the axle housing.
2. Install the new fill plug (MBA 6809900117) from the inside of the housing. See Fig. 6 and Fig. 7.
