35-040 Fixing eAxle Oil Seepage at the Shift to Neutral Tool/Plug Location

TSB-35-040-FTL

- ▶ eM2
- ▶ eCascadia

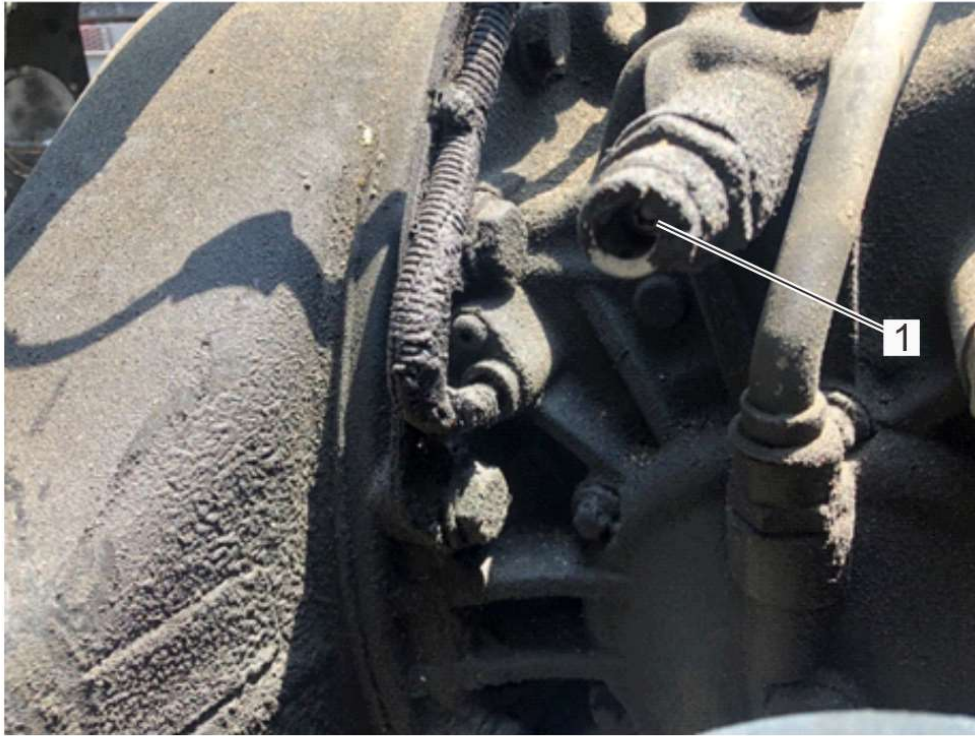
Fig. 1, Bolt Removal

1. Center Bolt

1. Park the vehicle on a level surface, shut down the vehicle, and set the parking brake. Chock the tires.
2. Clean the area around shift tool.
3. Remove the center bolt using a long T30 Torx driver. See Figure 1.
