# 42–080 ABS Wheel Speed Fault Code Correction for MBSP Equipped Vehicles

## TSB-42-080-FTL

► New Cascadia

### Described Condition

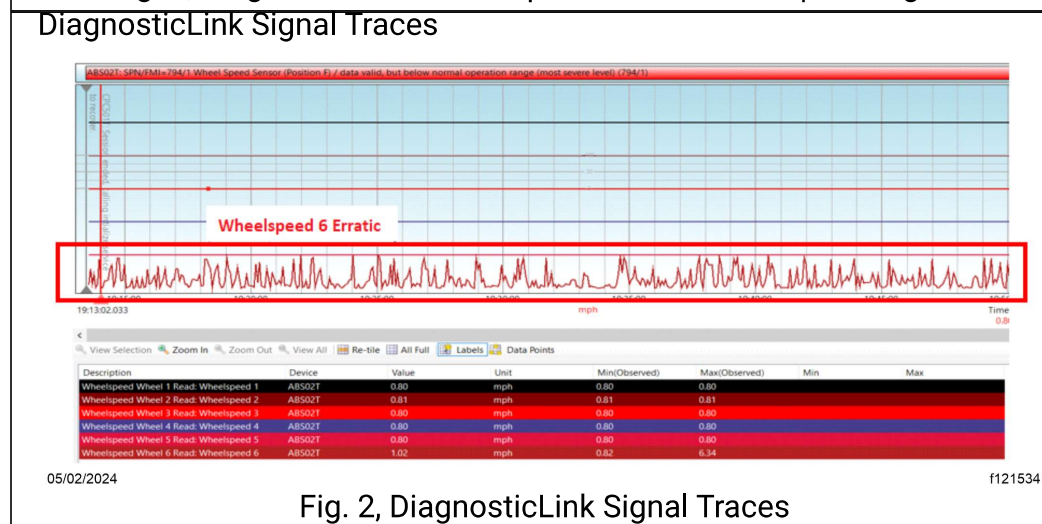
Fig. 2, DiagnosticLink Signal Traces

14. ☐ See Fig. 2 for the traces of the selected wheel speed and relative speed signals. Note the erratic signal on wheel speed 6.

- a. ☐ If the readings are erratic regardless of location, or if the issue only happens in damp or wet conditions, install the individual overlays for all four rear wheel ends. See Table. [WABCO Harness Part Numbers 4](#) for length and part number of WABCO harnesses.
- Table 4, WABCO Harness Part Numbers
